# Long Span Timber Structures with Composite Action – from disaster to success

Nils Ivar Bovim  
Norway

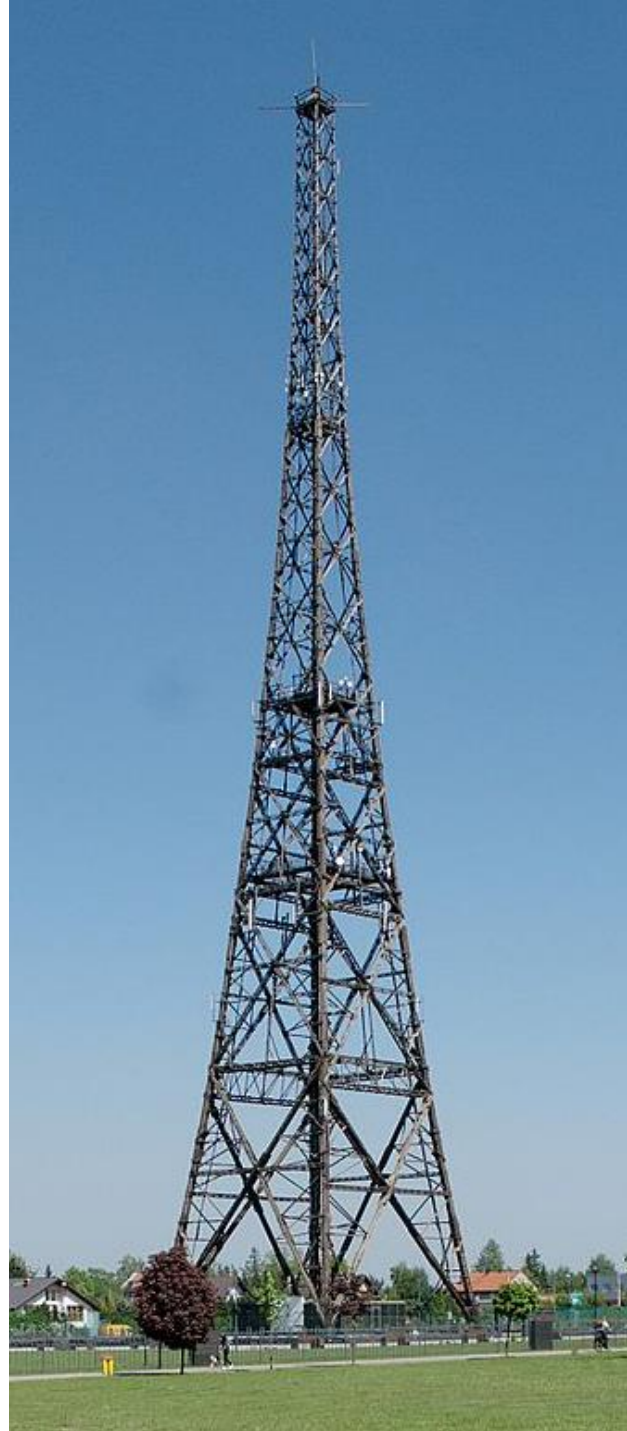
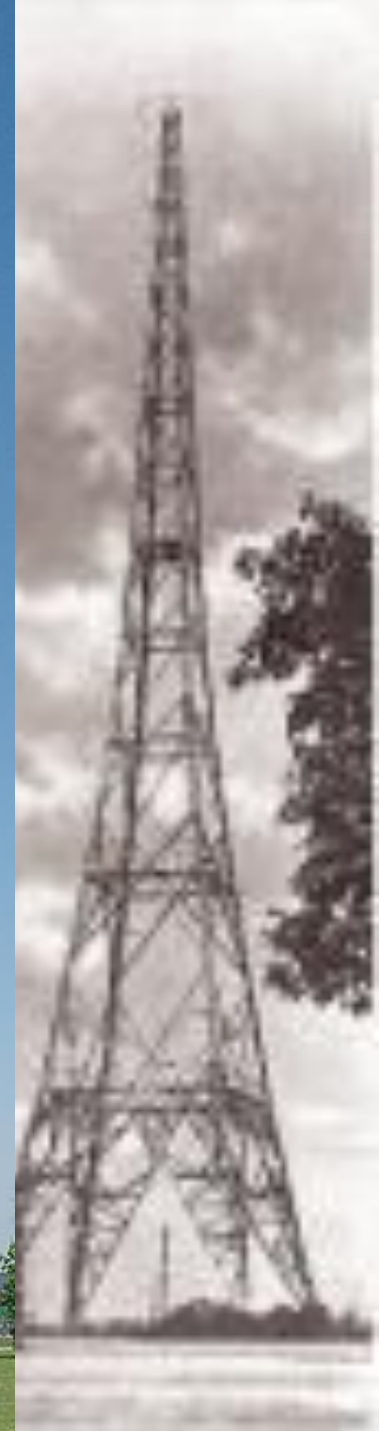
# Mühlacker transmission tower made of timber

In 1933-34, a 190 m high wooden tower was built - the tallest structure ever built !!

The radio tower was built for antennas with transmission power of 100 kW.

On April 6, 1945, the wooden tower and the masts carrying the system of T-antennas were blown up by the SS to prevent its capture by the Allies in World War II.

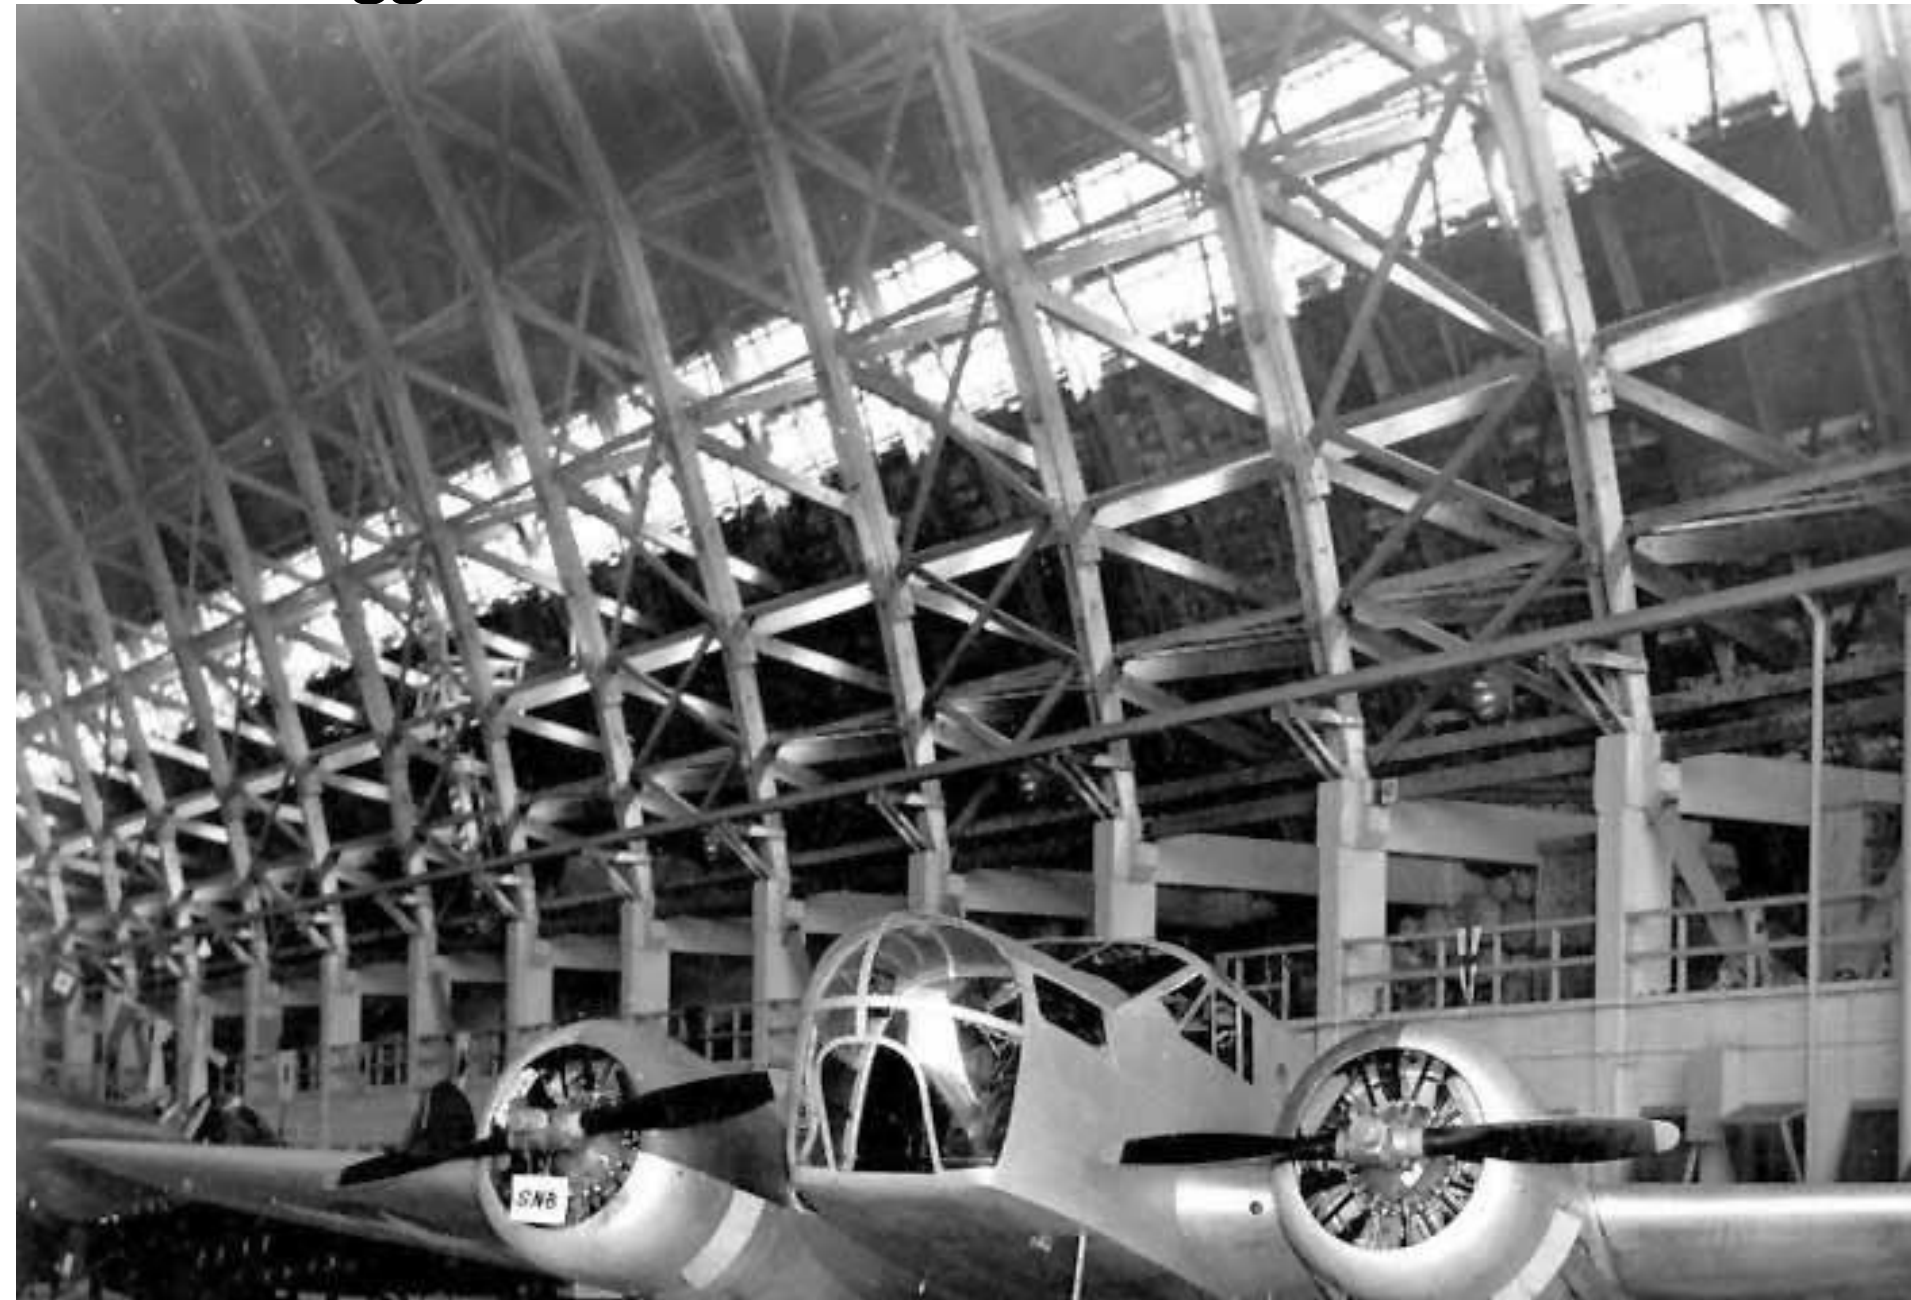
# World's biggest ...: Detail of structure

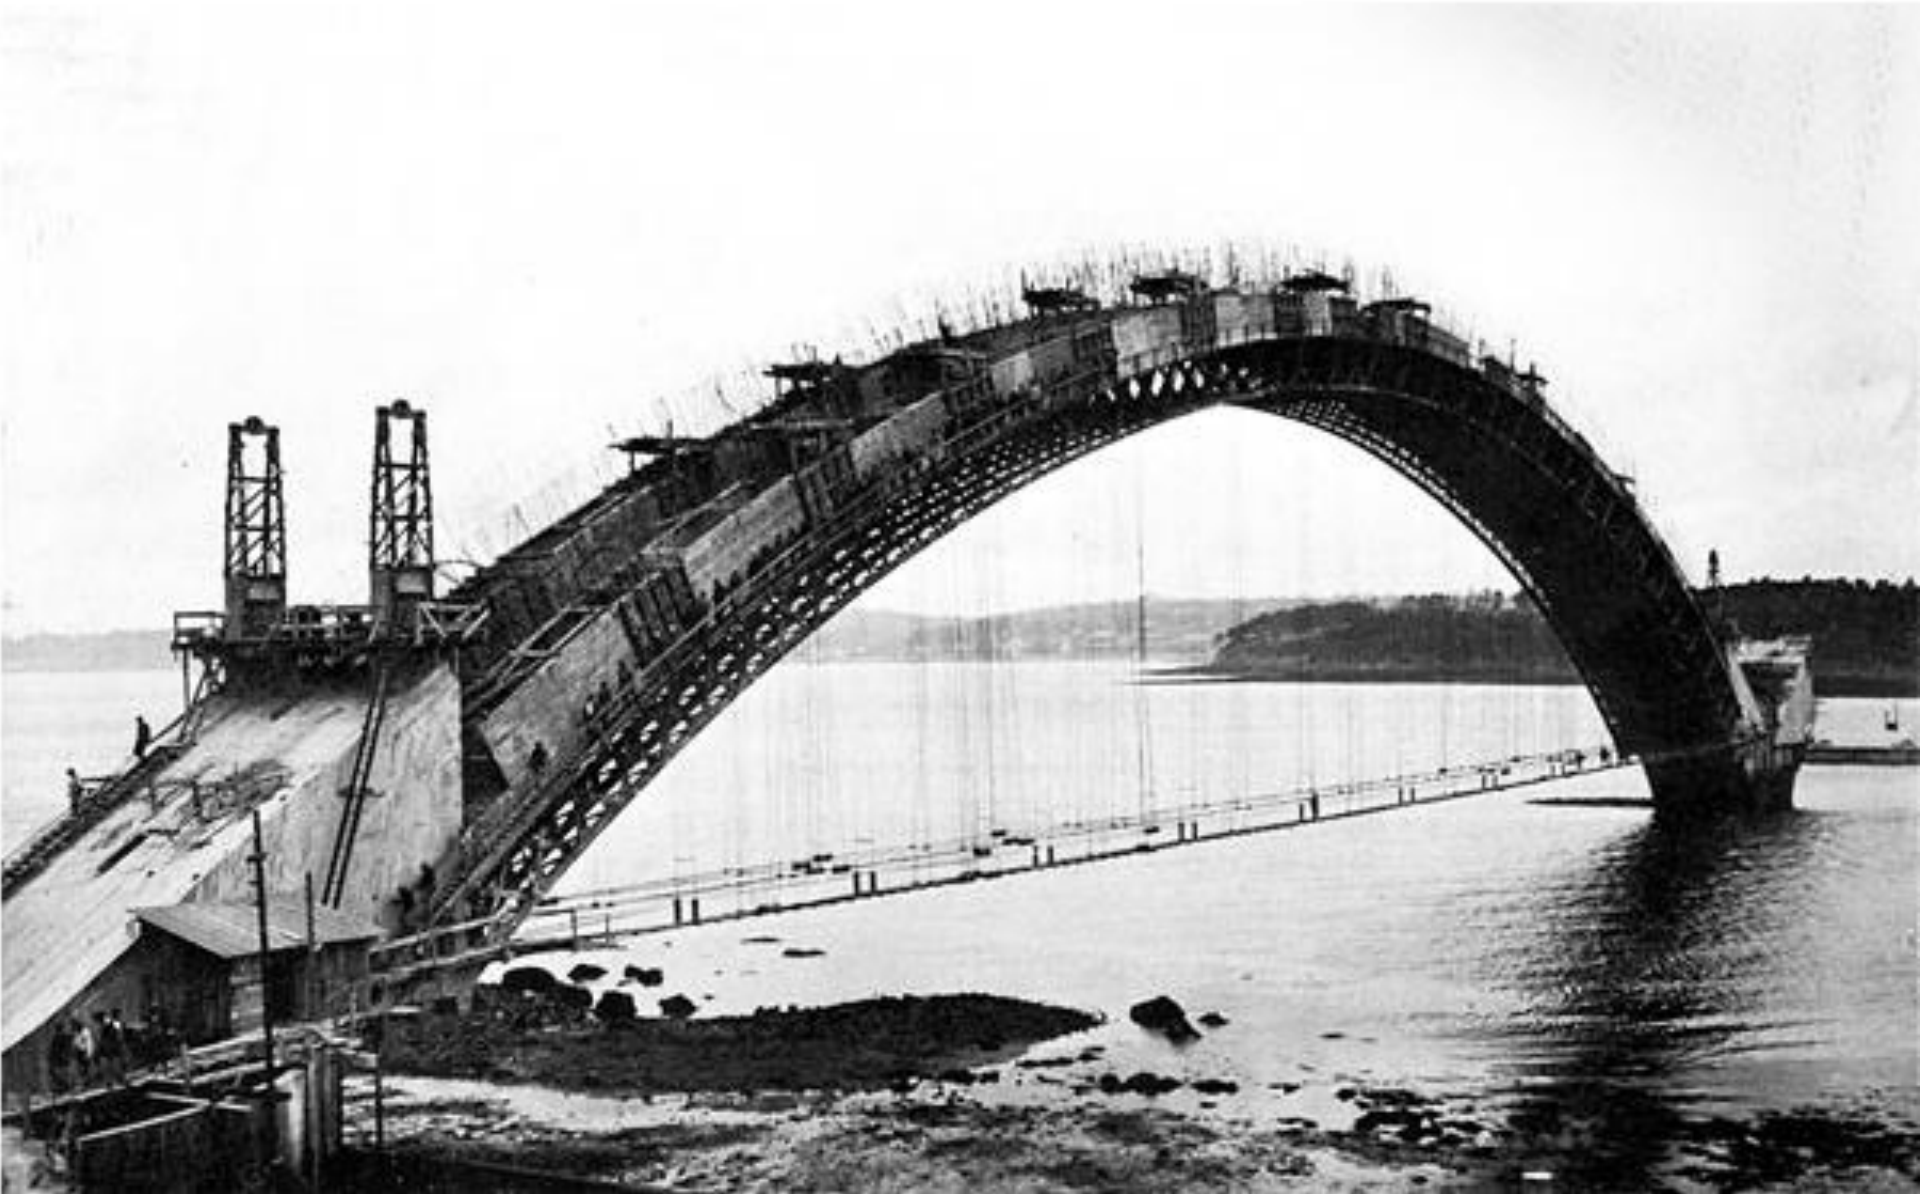
**The formwork was built with steel framework**

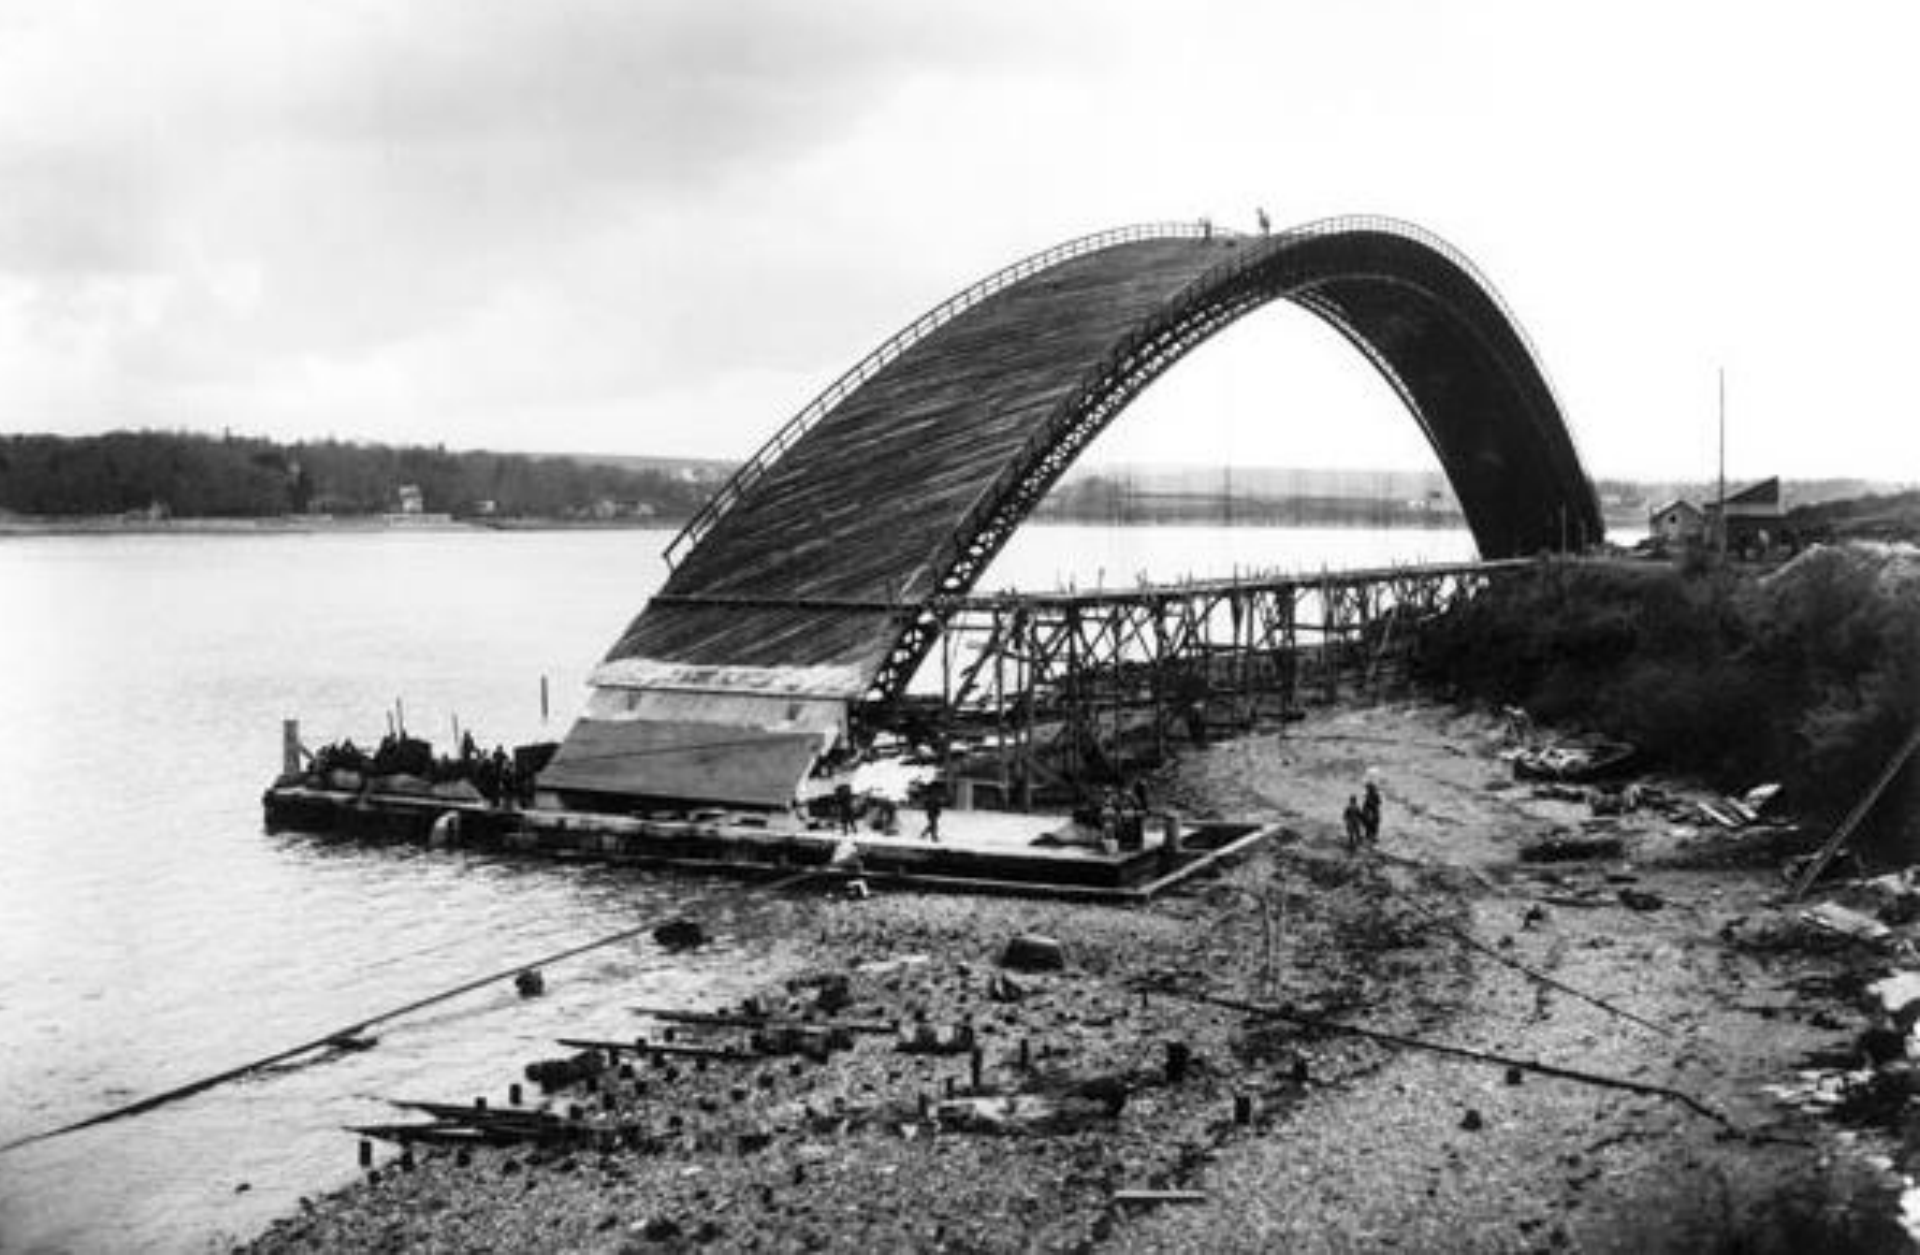
Formwork cladding of diagonal timber boards

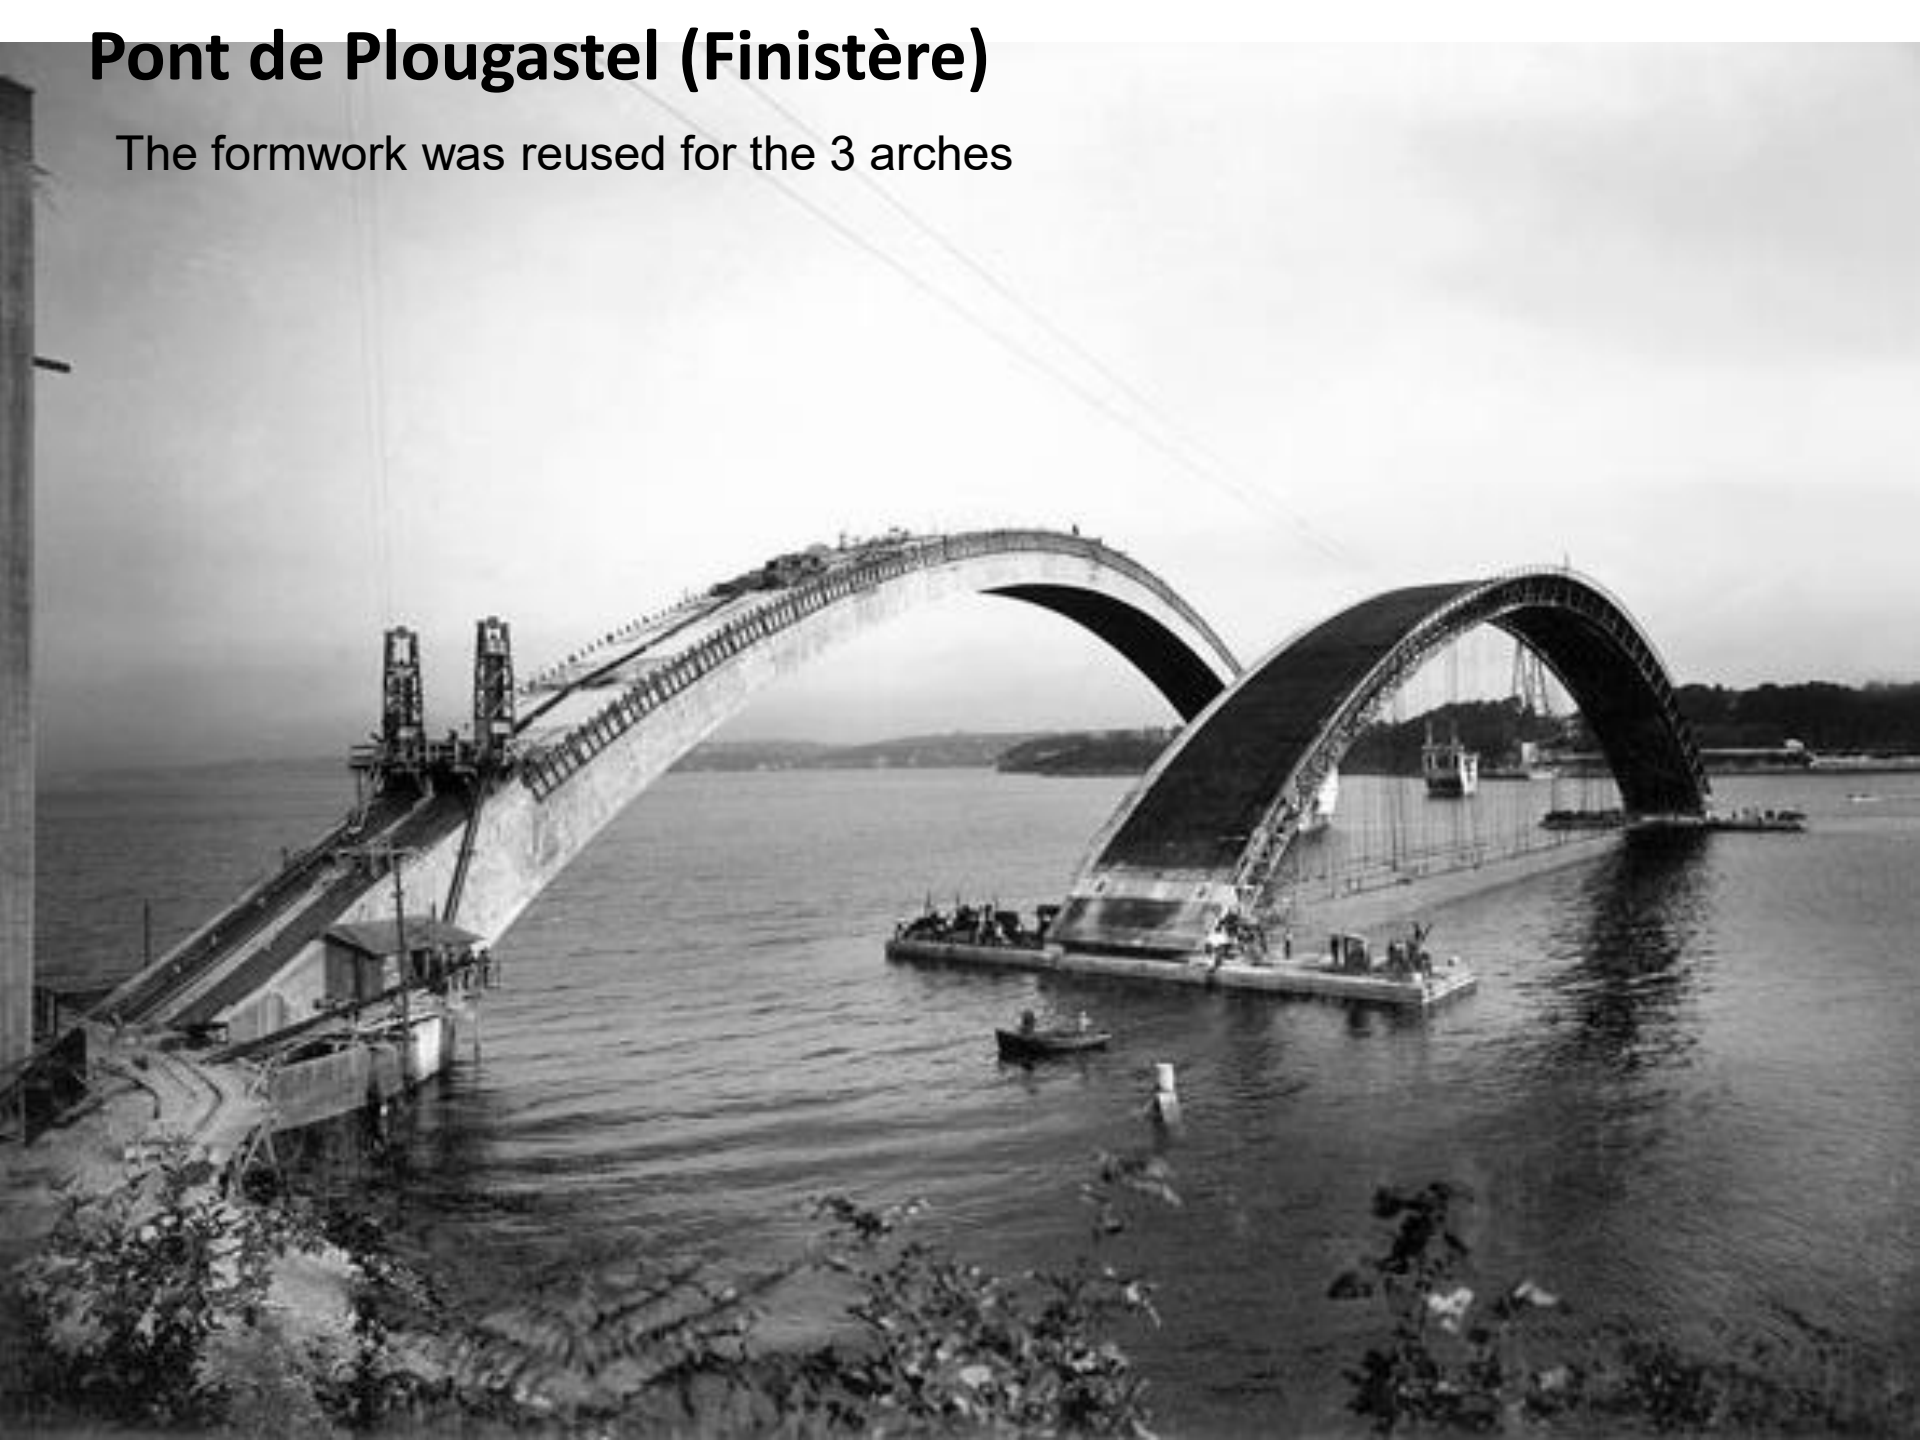
The formwork was reused for the 3 arches

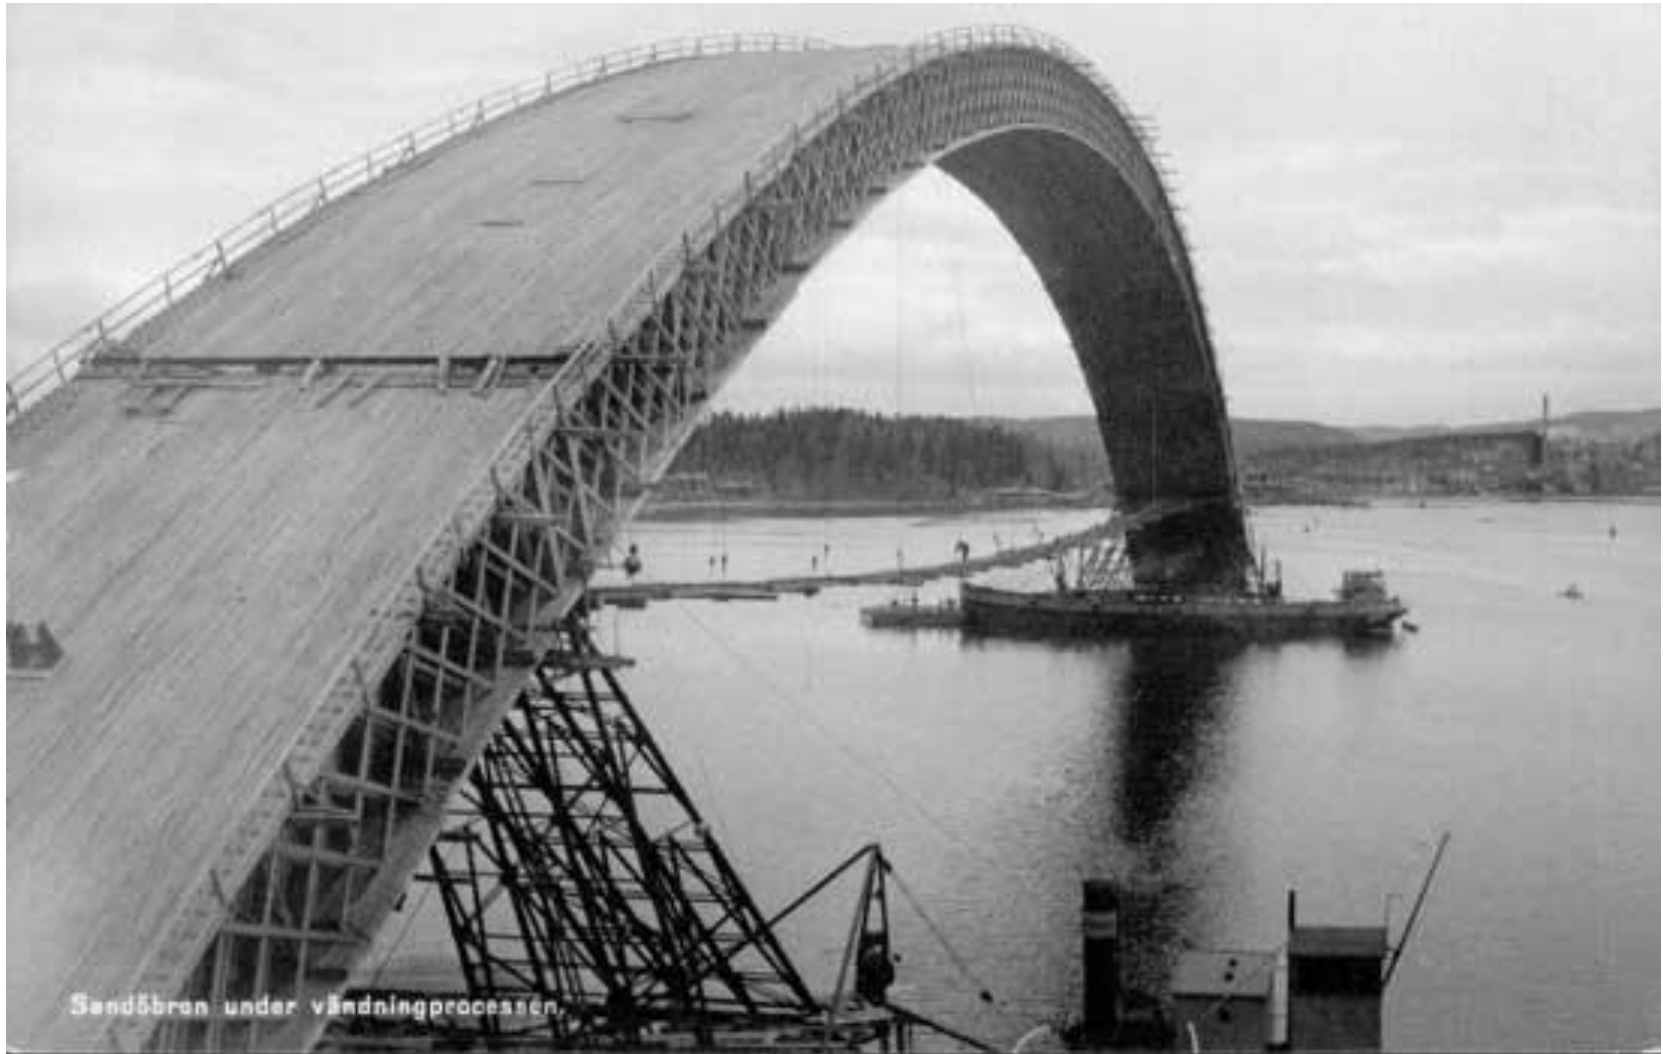
Formwork and scaffolding were buildt on the riverbank

The scaffolding towers were removed an **the whole structure transported across the river with boats** at the 18th of May, 1939

Upper and lower chord is parallel nailed (12" nails) massiv wood structure with nailed diagonals in between. **Thickness of the chords is only 200 mm!**

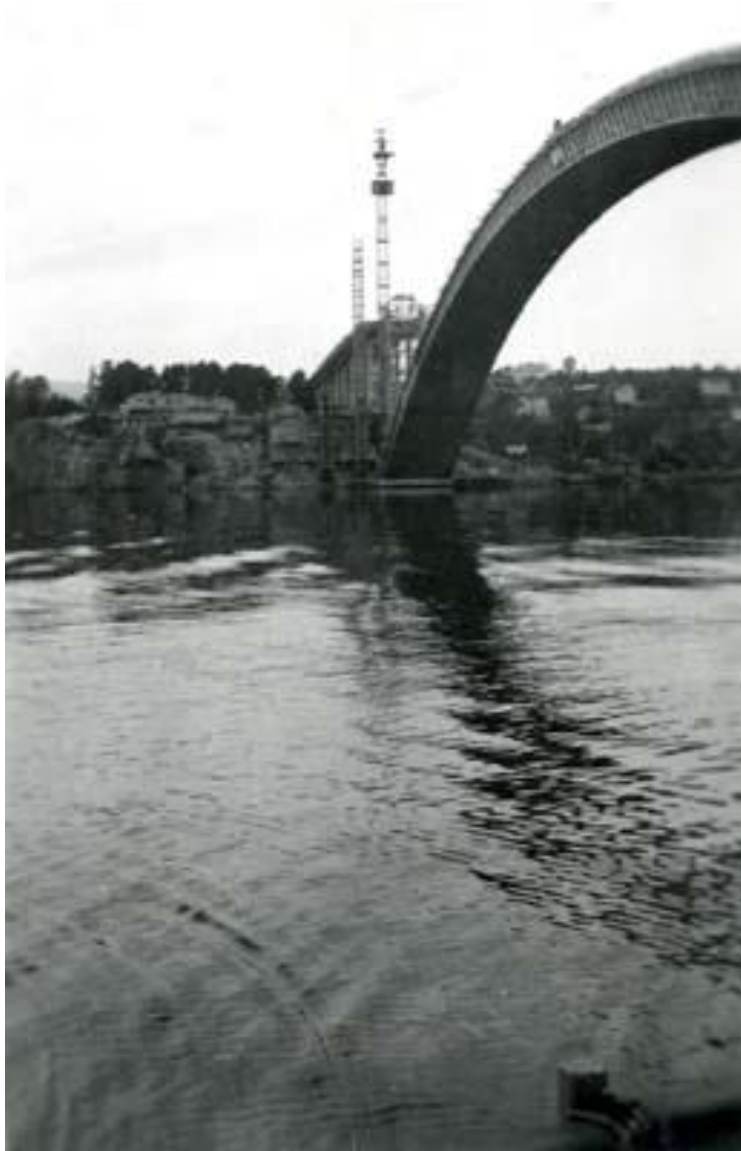
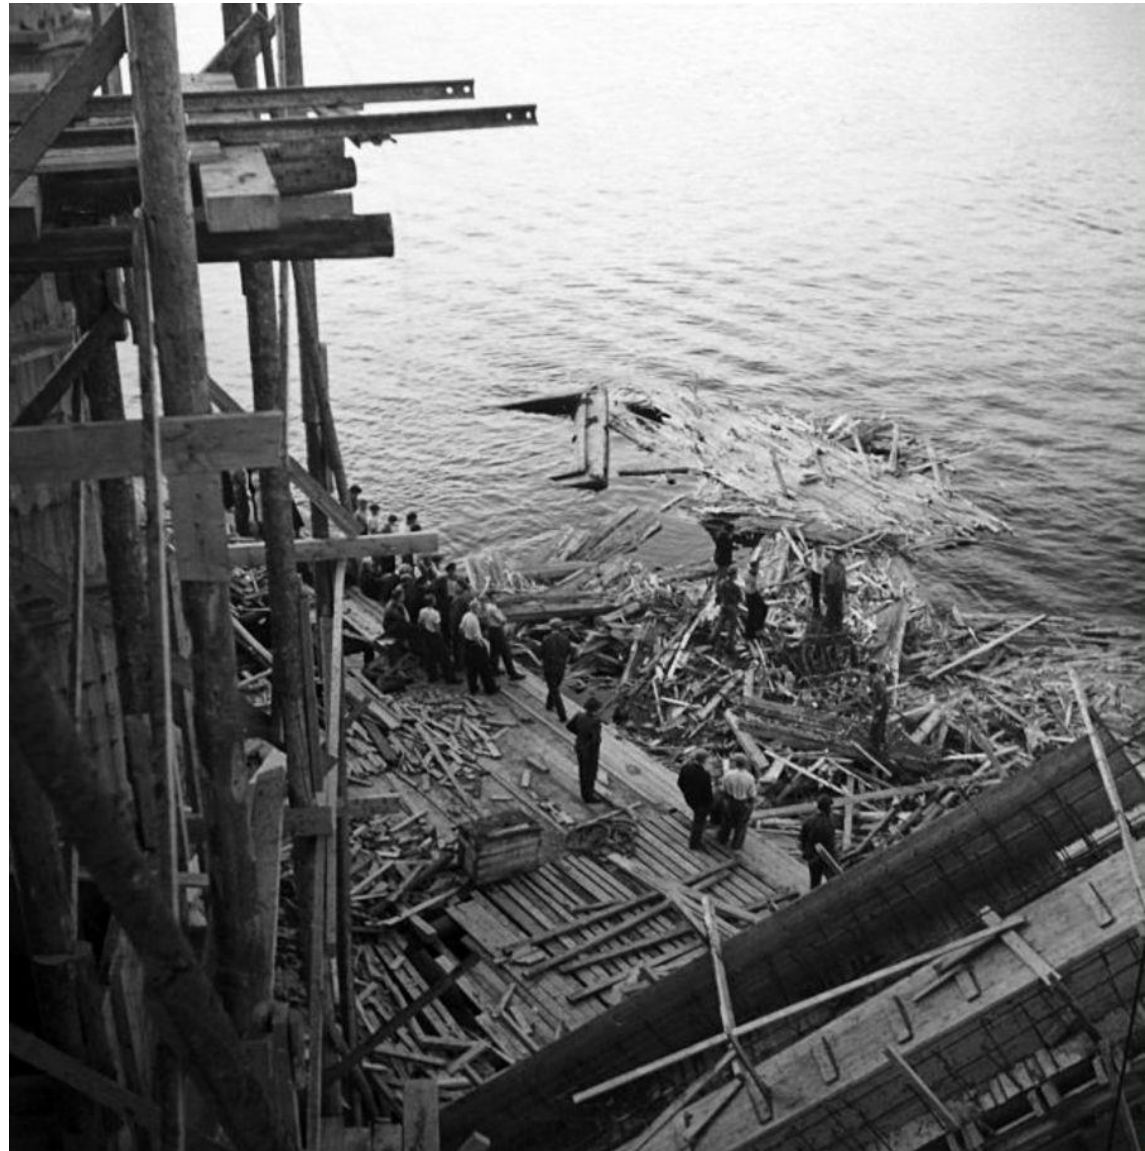
30. August, 1939 - only 12 m from finishing the concrete casting (!) - a huge sound was heard and the complete structure collapsed

Witness descriptions indicated **buckling in vertical direction (in plane) of the whole section as the failure mode.**

The investigating committee stated that the failure was caused by insufficient strength/stiffness of the transverse bracing between the two flanges.

Later investigations have proposed lateral instability of the arch as responsible for the failure

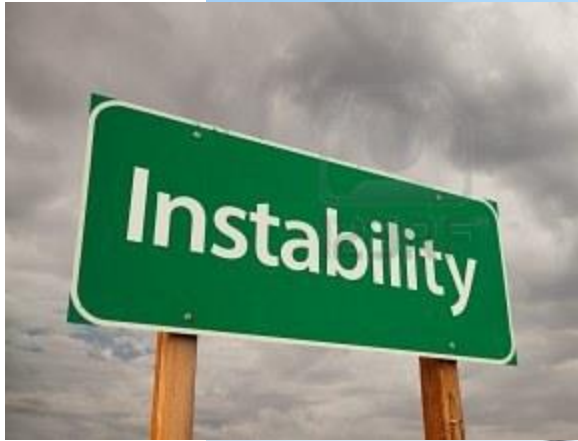
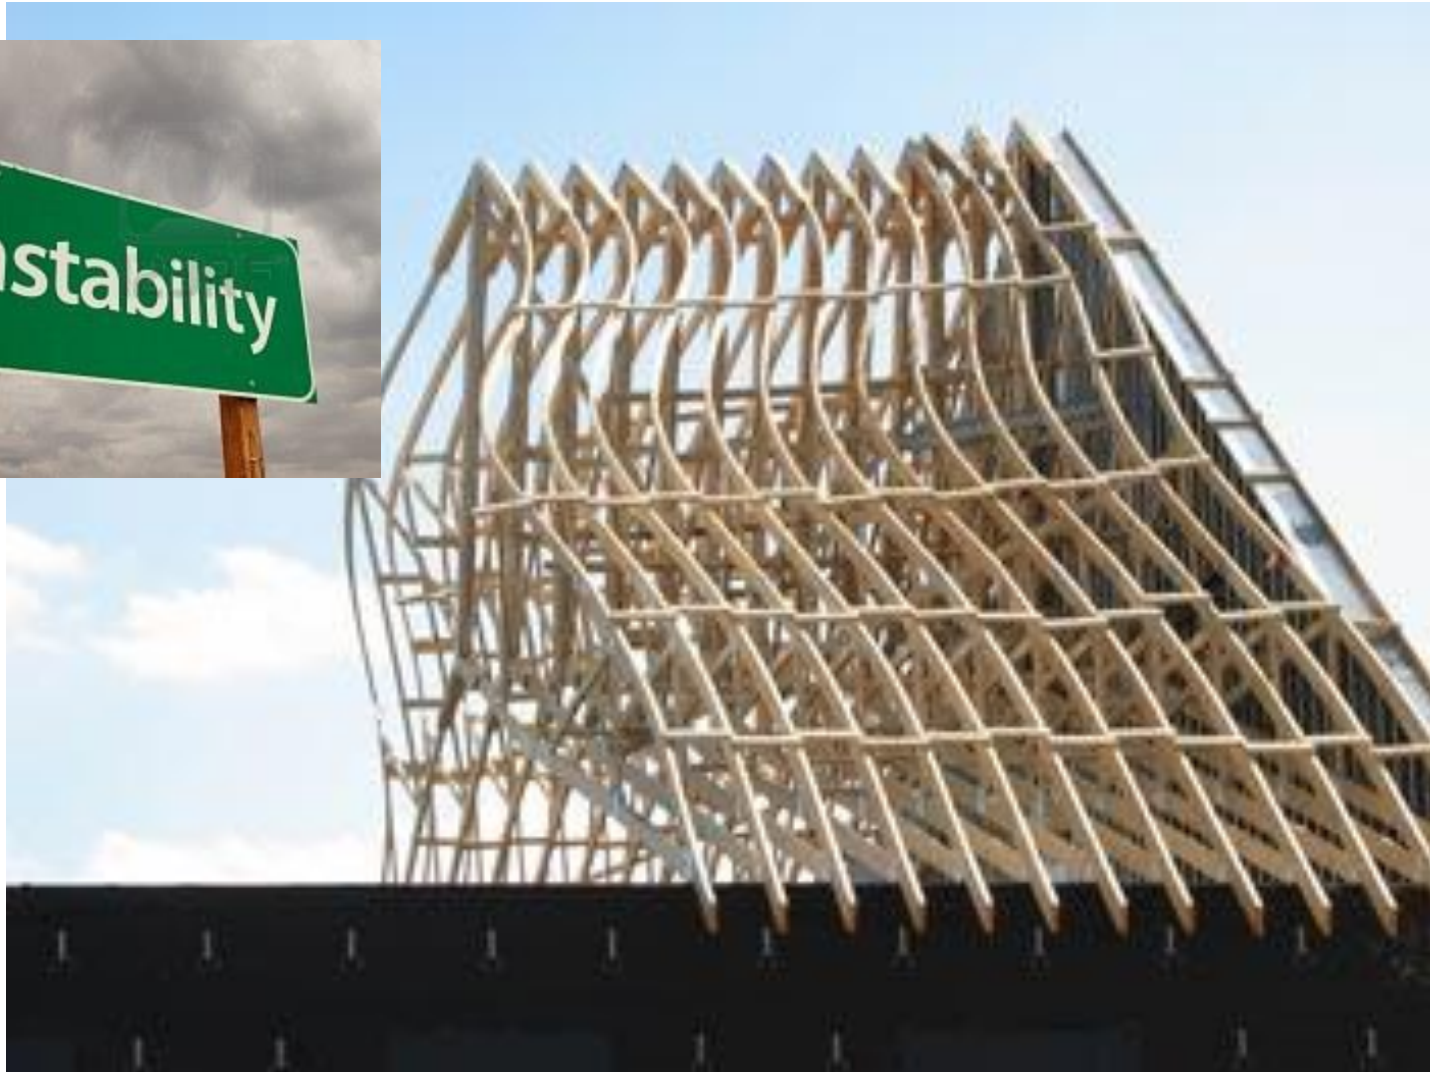
Photo taken about 10 seconds before the 52' scissor trusses collapsed. There was no wind or snow loads, only dead load from the trusses! The top chord is buckling from a lack of proper top chord bracing

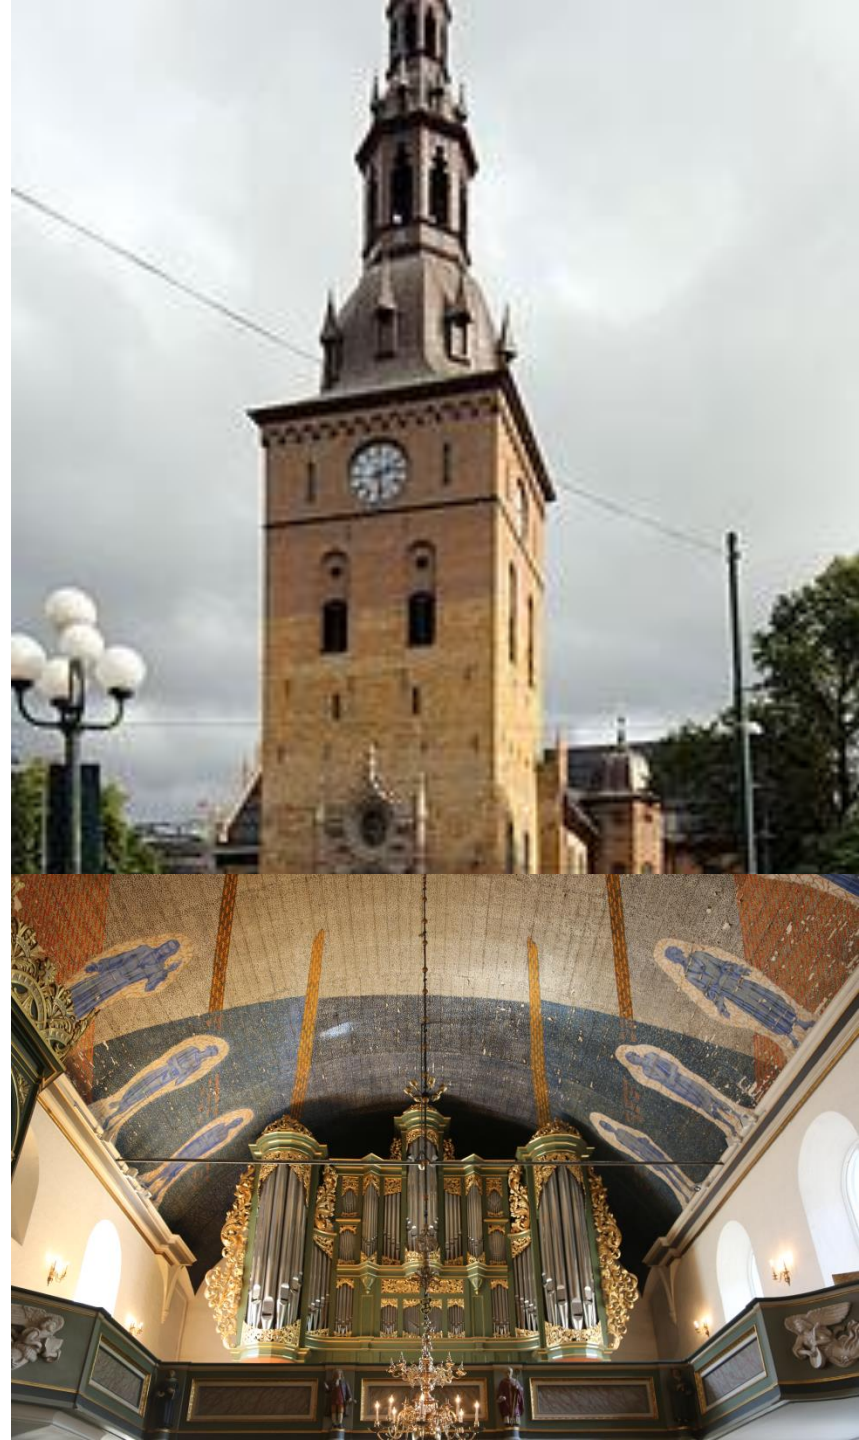
- Vaulted ceiling and scissor trusses
- The bracing system was cut (!) because a new organ demanded more space

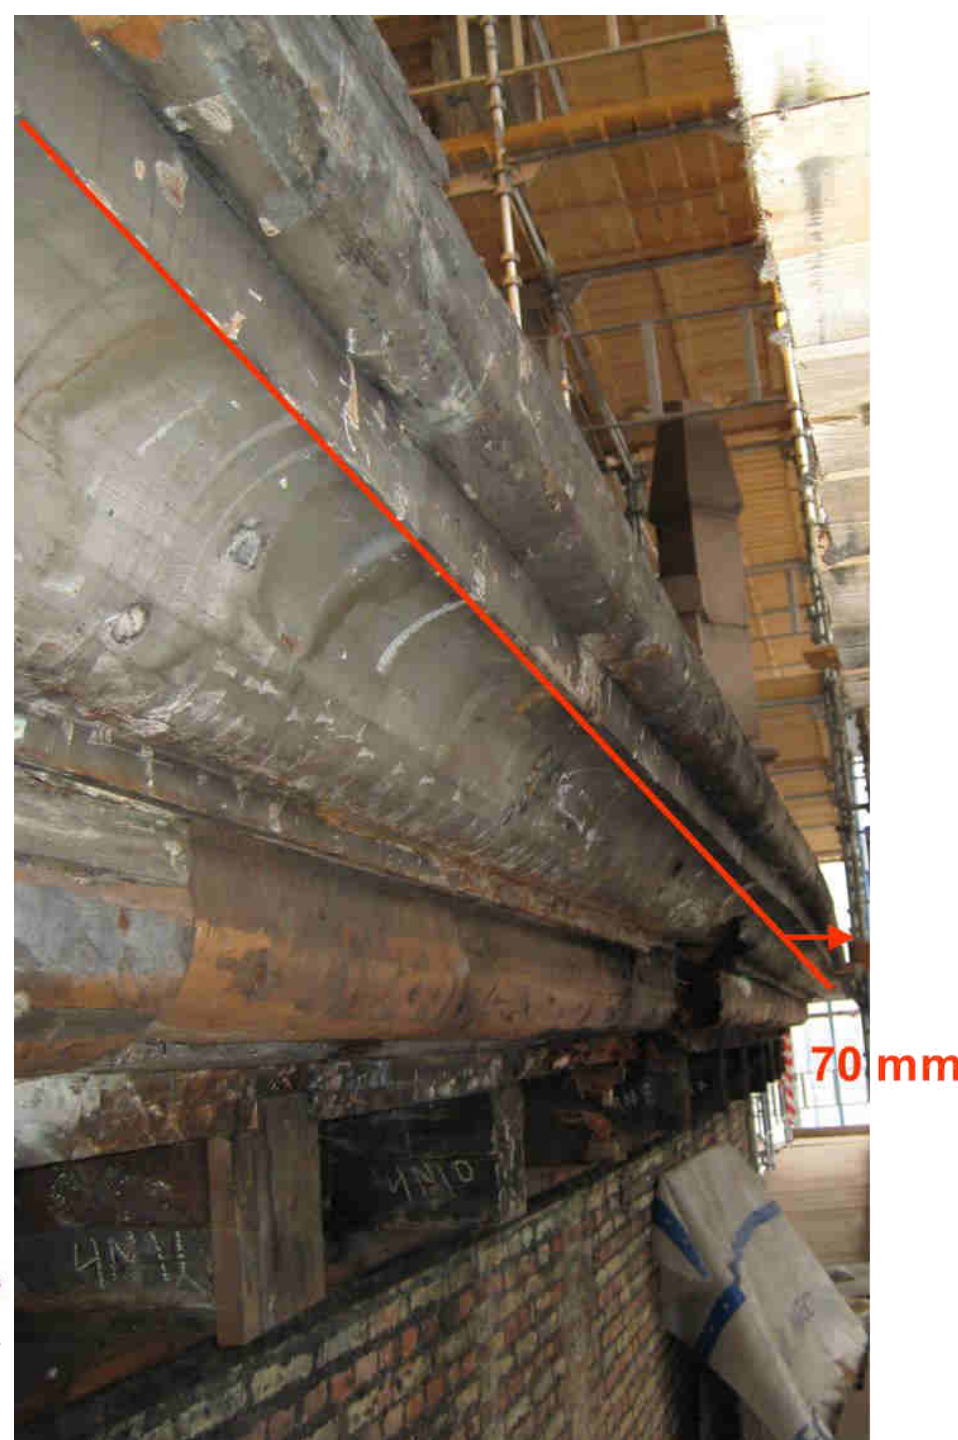
- Vaulted ceiling and scissor trusses
- The bracing system was cut (!) because a new organ demanded more space
- Horizontal reaction forces tend to push external walls outwards (70 mm)

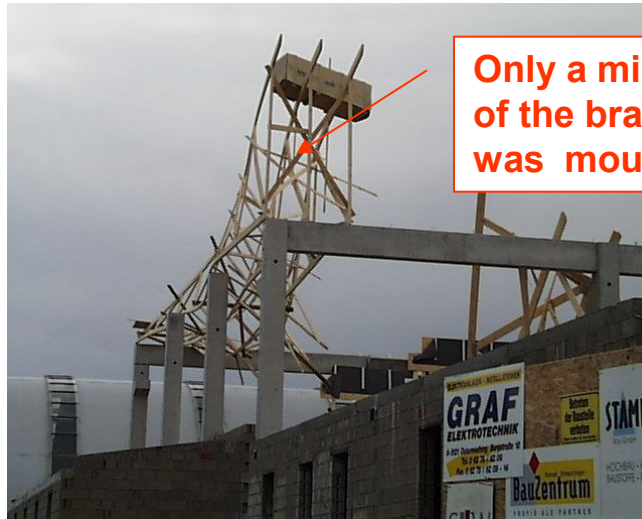
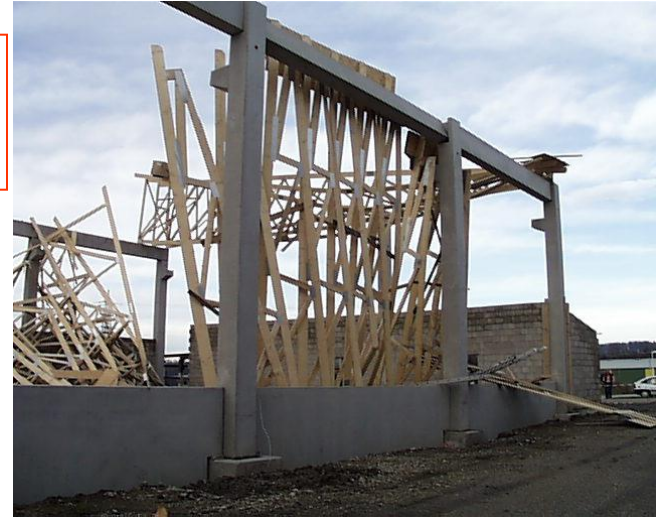
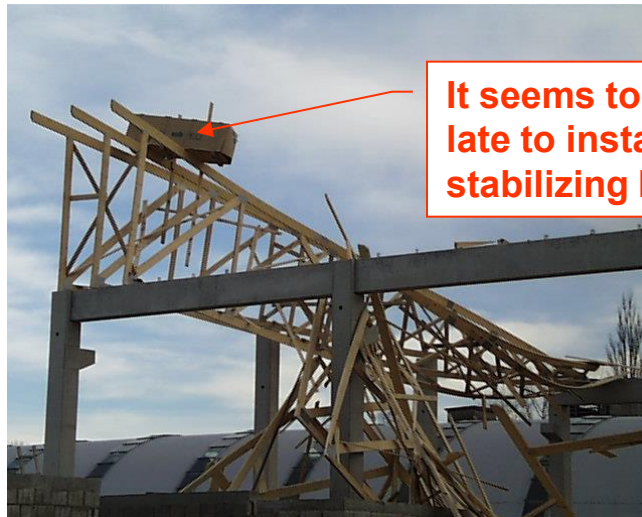
**Only a minor part  
of the bracing system  
was mounted!**

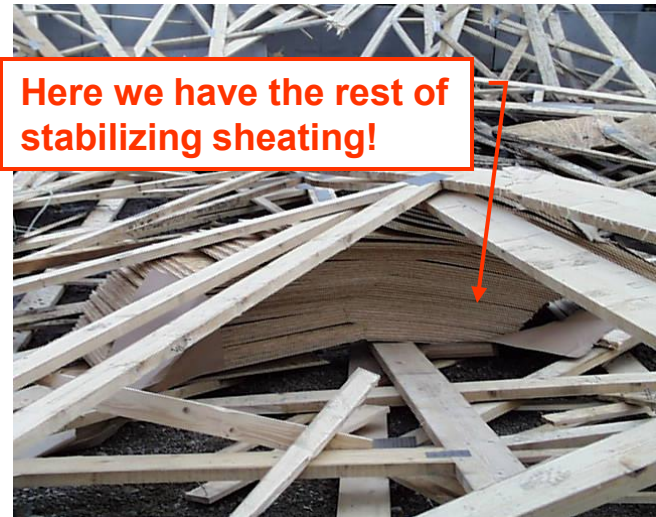
**It seems too  
late to install this  
stabilizing boards!**
