# Long Span Timber Structures with Composite Action – from disaster to success

Nils Ivar Bovim  
Norway

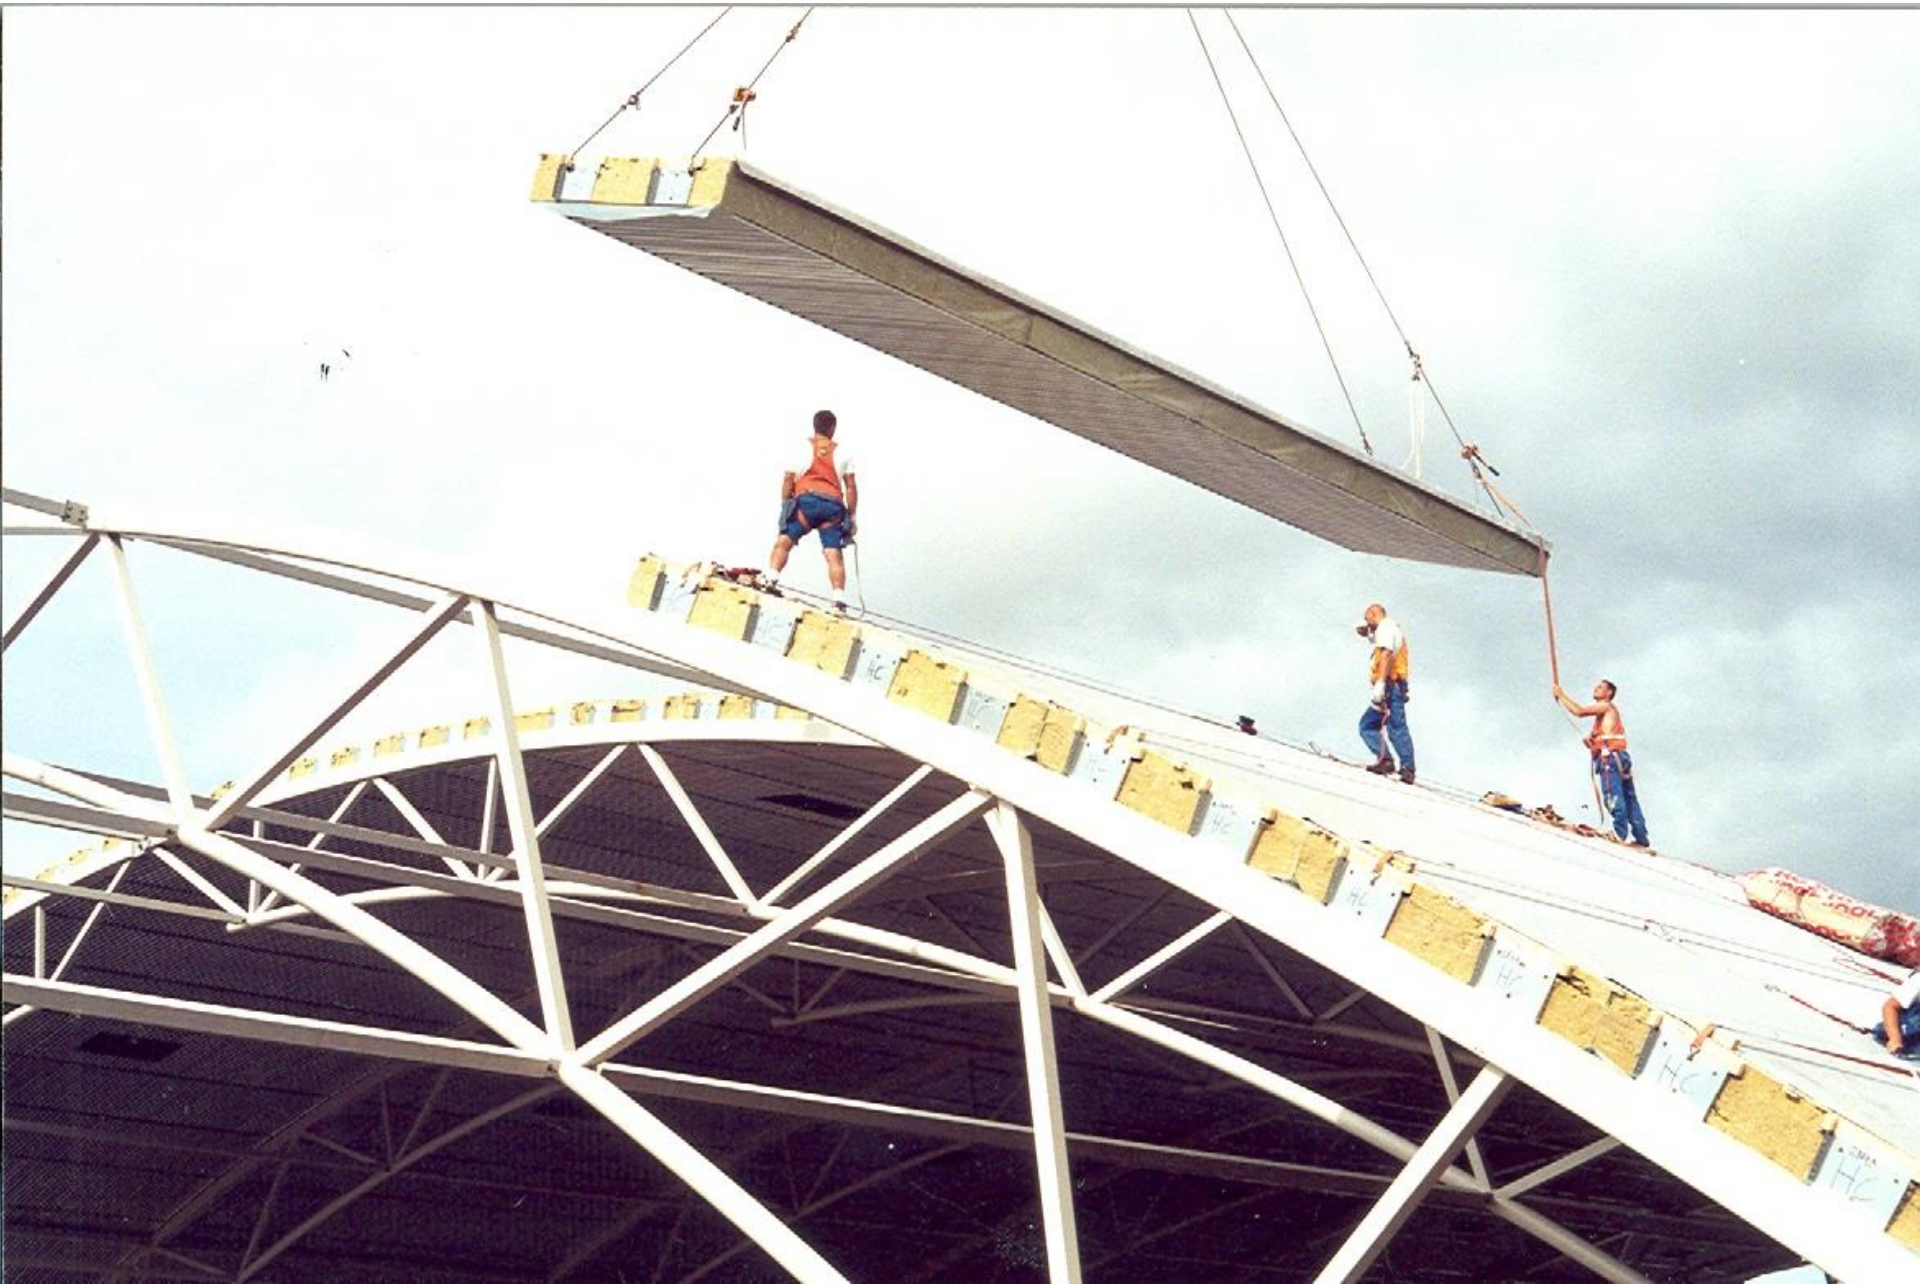
# **Lett-Tak roof panel system with composite action of plywood, timber and steel**

- **Located in Larvik, Norway**
- **Yearly production capacity 300 000 m<sup>2</sup>**
- **Advanced product, full control from production to finished roof**
- **Several projects also in Sweden, Denmark, Iceland, Germany**
- **Dead weight 0,4 - 0,5 kN/m<sup>2</sup>**
- **Insulation: U-values from 0,18 – 0,07 [W/m<sup>2</sup>K]**
- **Fire resistance up to 90 min.**
- **Max span width 18 m**

All mounting and fixing work is done from above

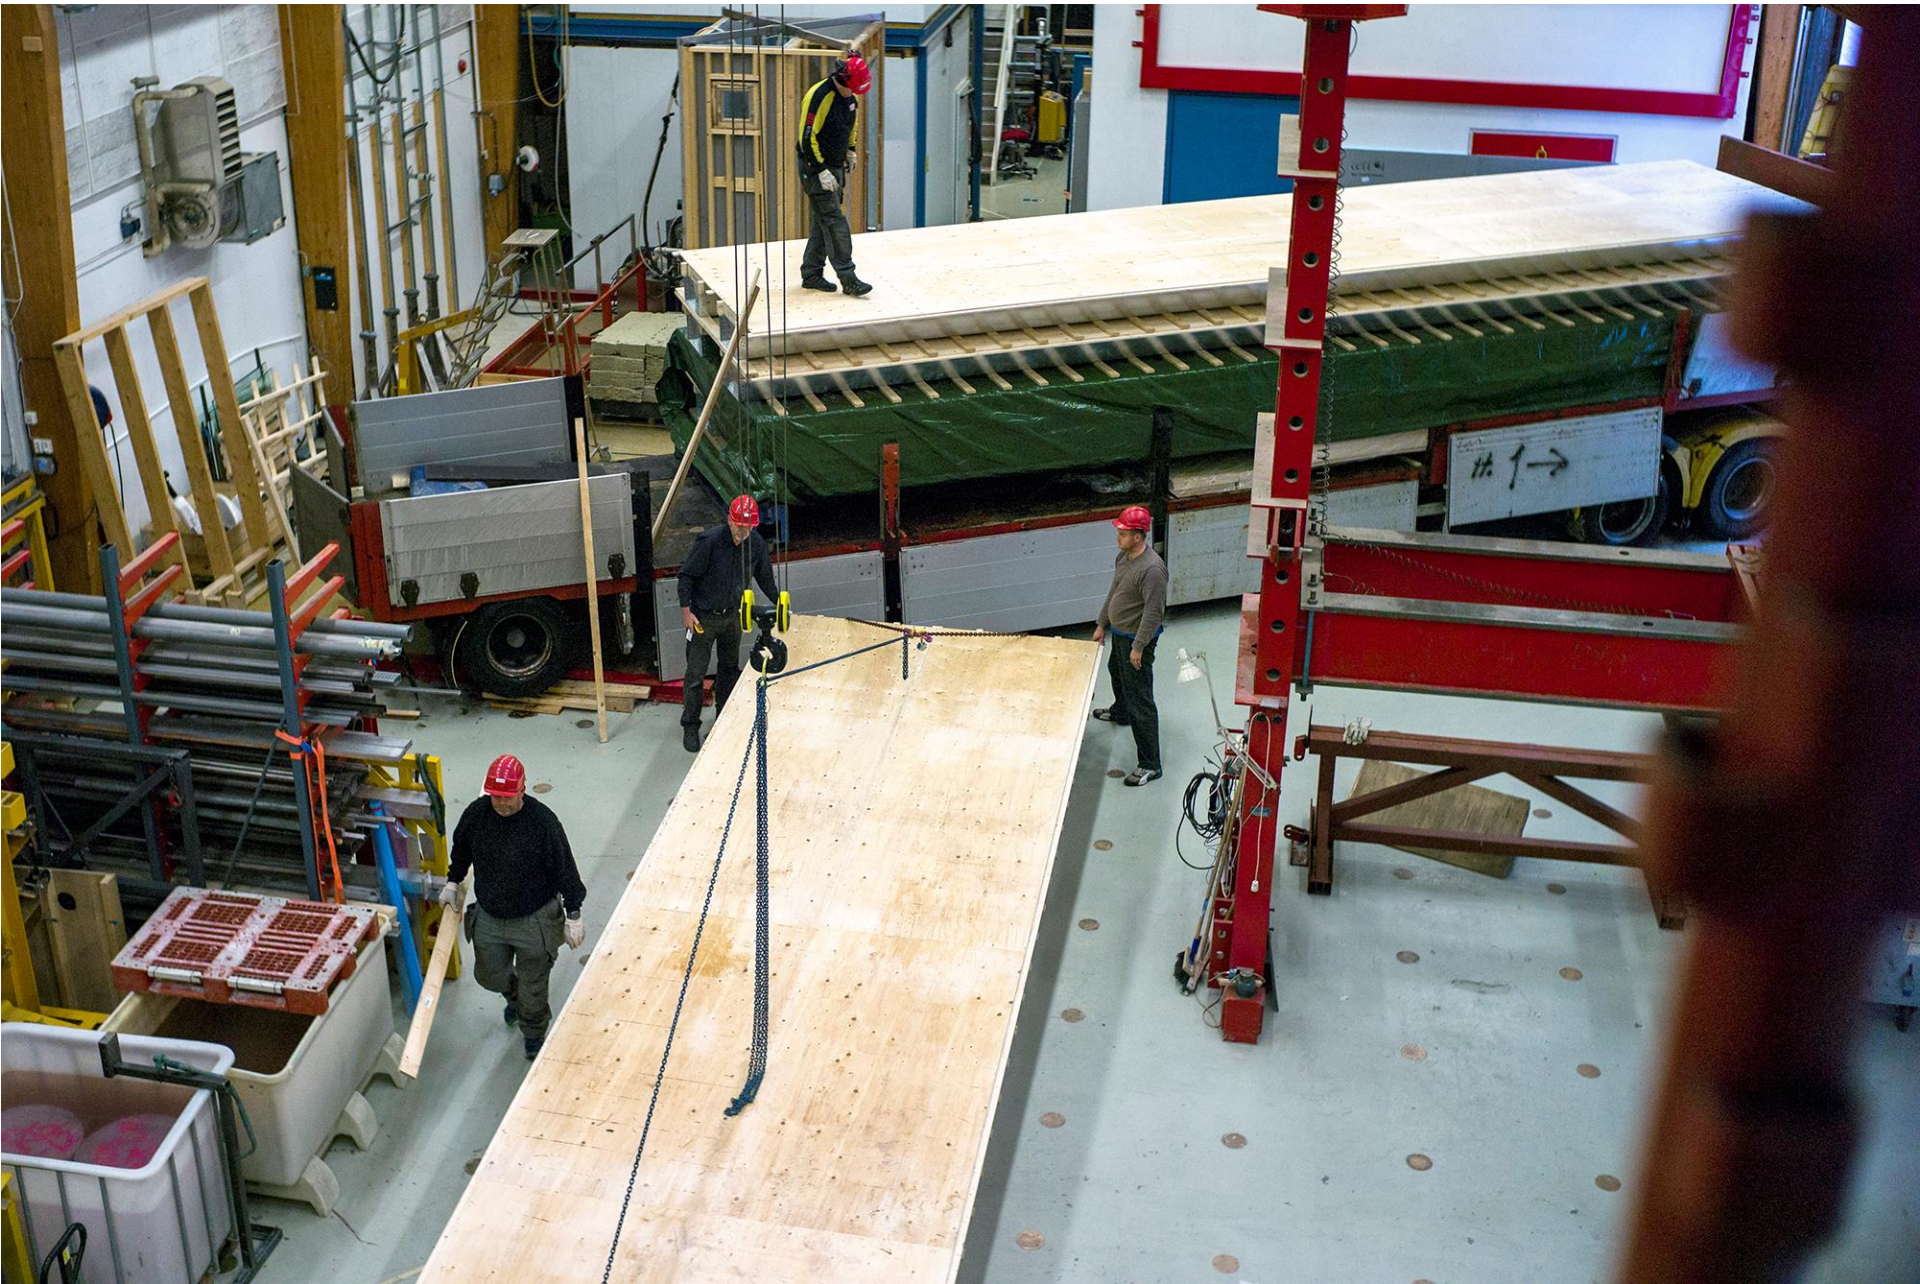
# Full scale test, 10 m Lett-Tak roof panels at the Norwegian Building Research Institute for European Technical Approval (ETA) 2015

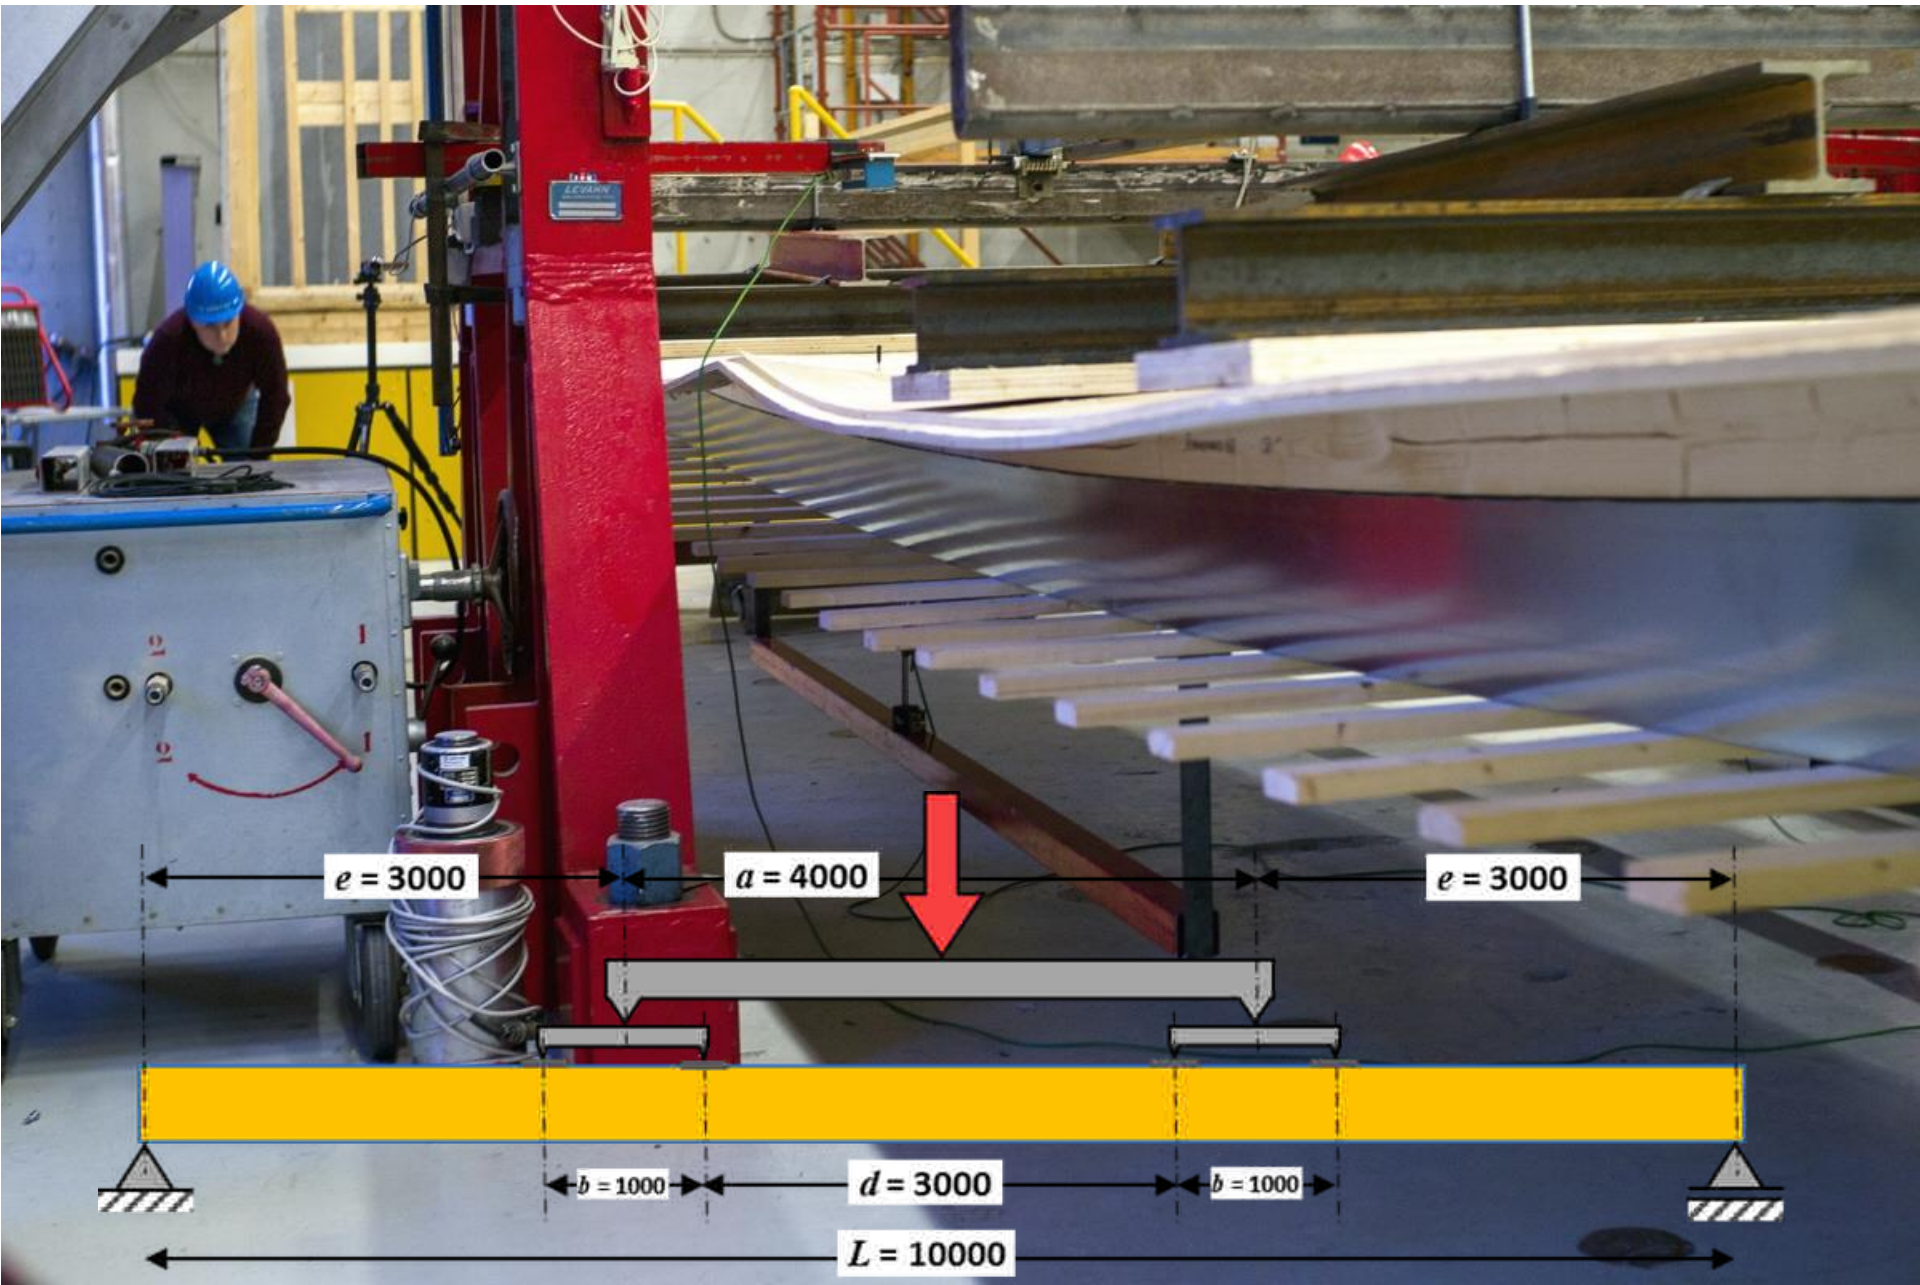
# From the full scale test of four Lett-Tak roof panels

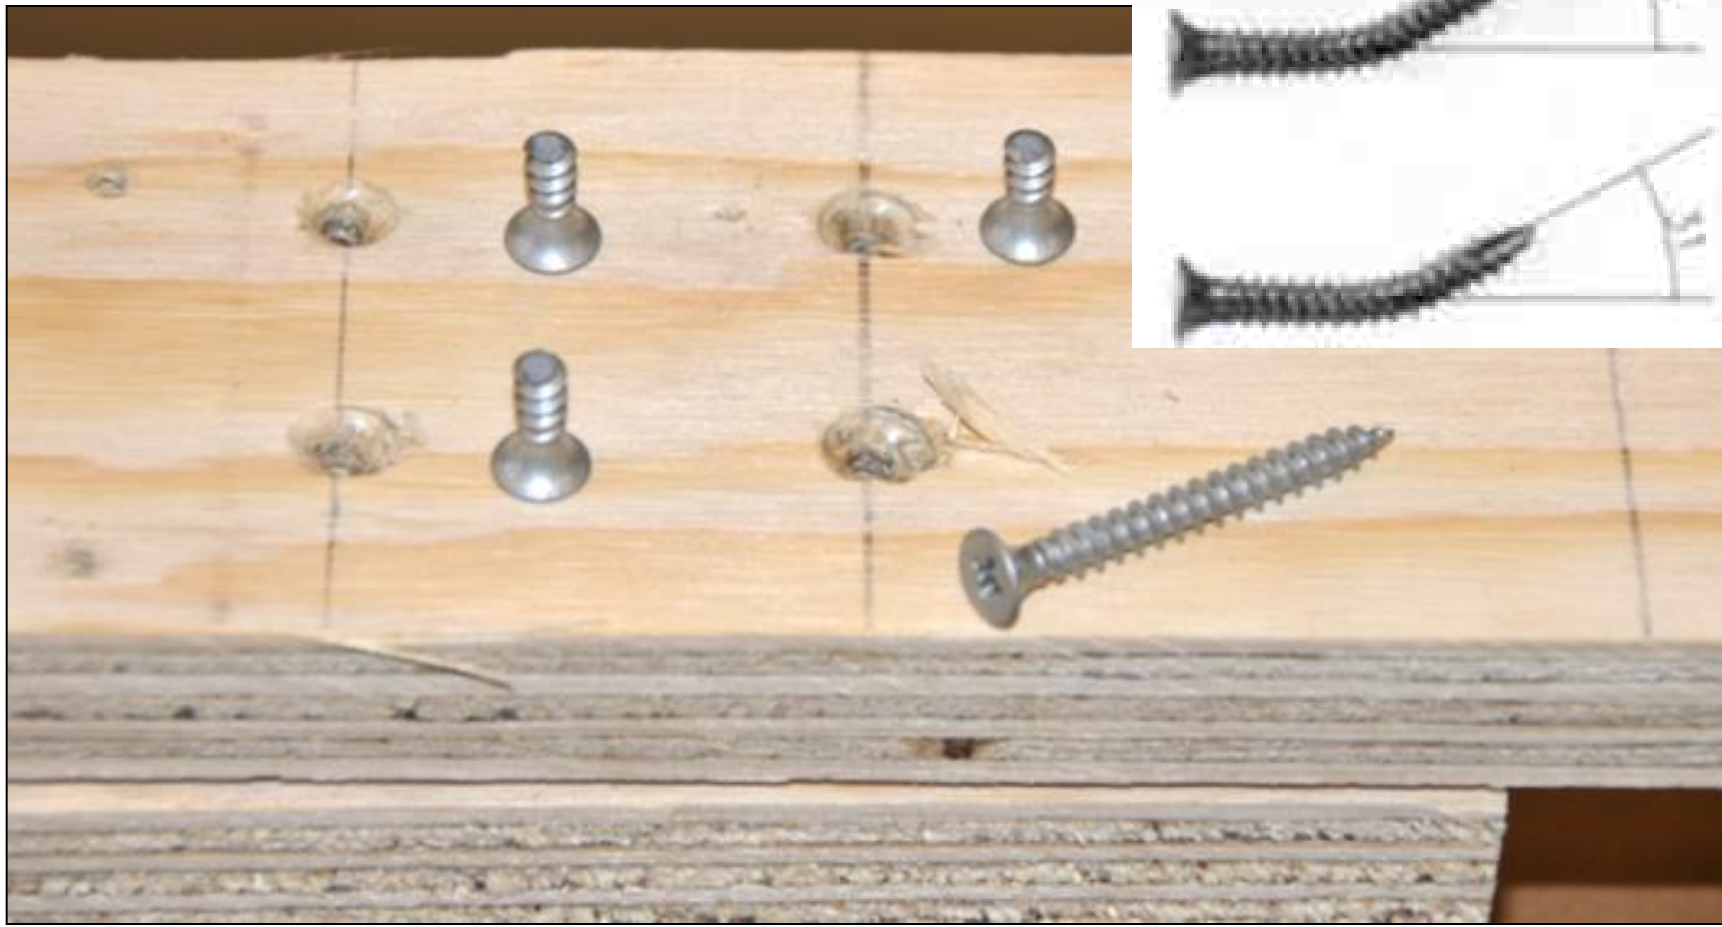
# Screws in diaphragm structures

- Some screws shows brittle failures, before bending!
- Always bend some screws by hand to confirm the ductility!
- Bending to  $20\text{-}25^\circ$  before failure is ok !

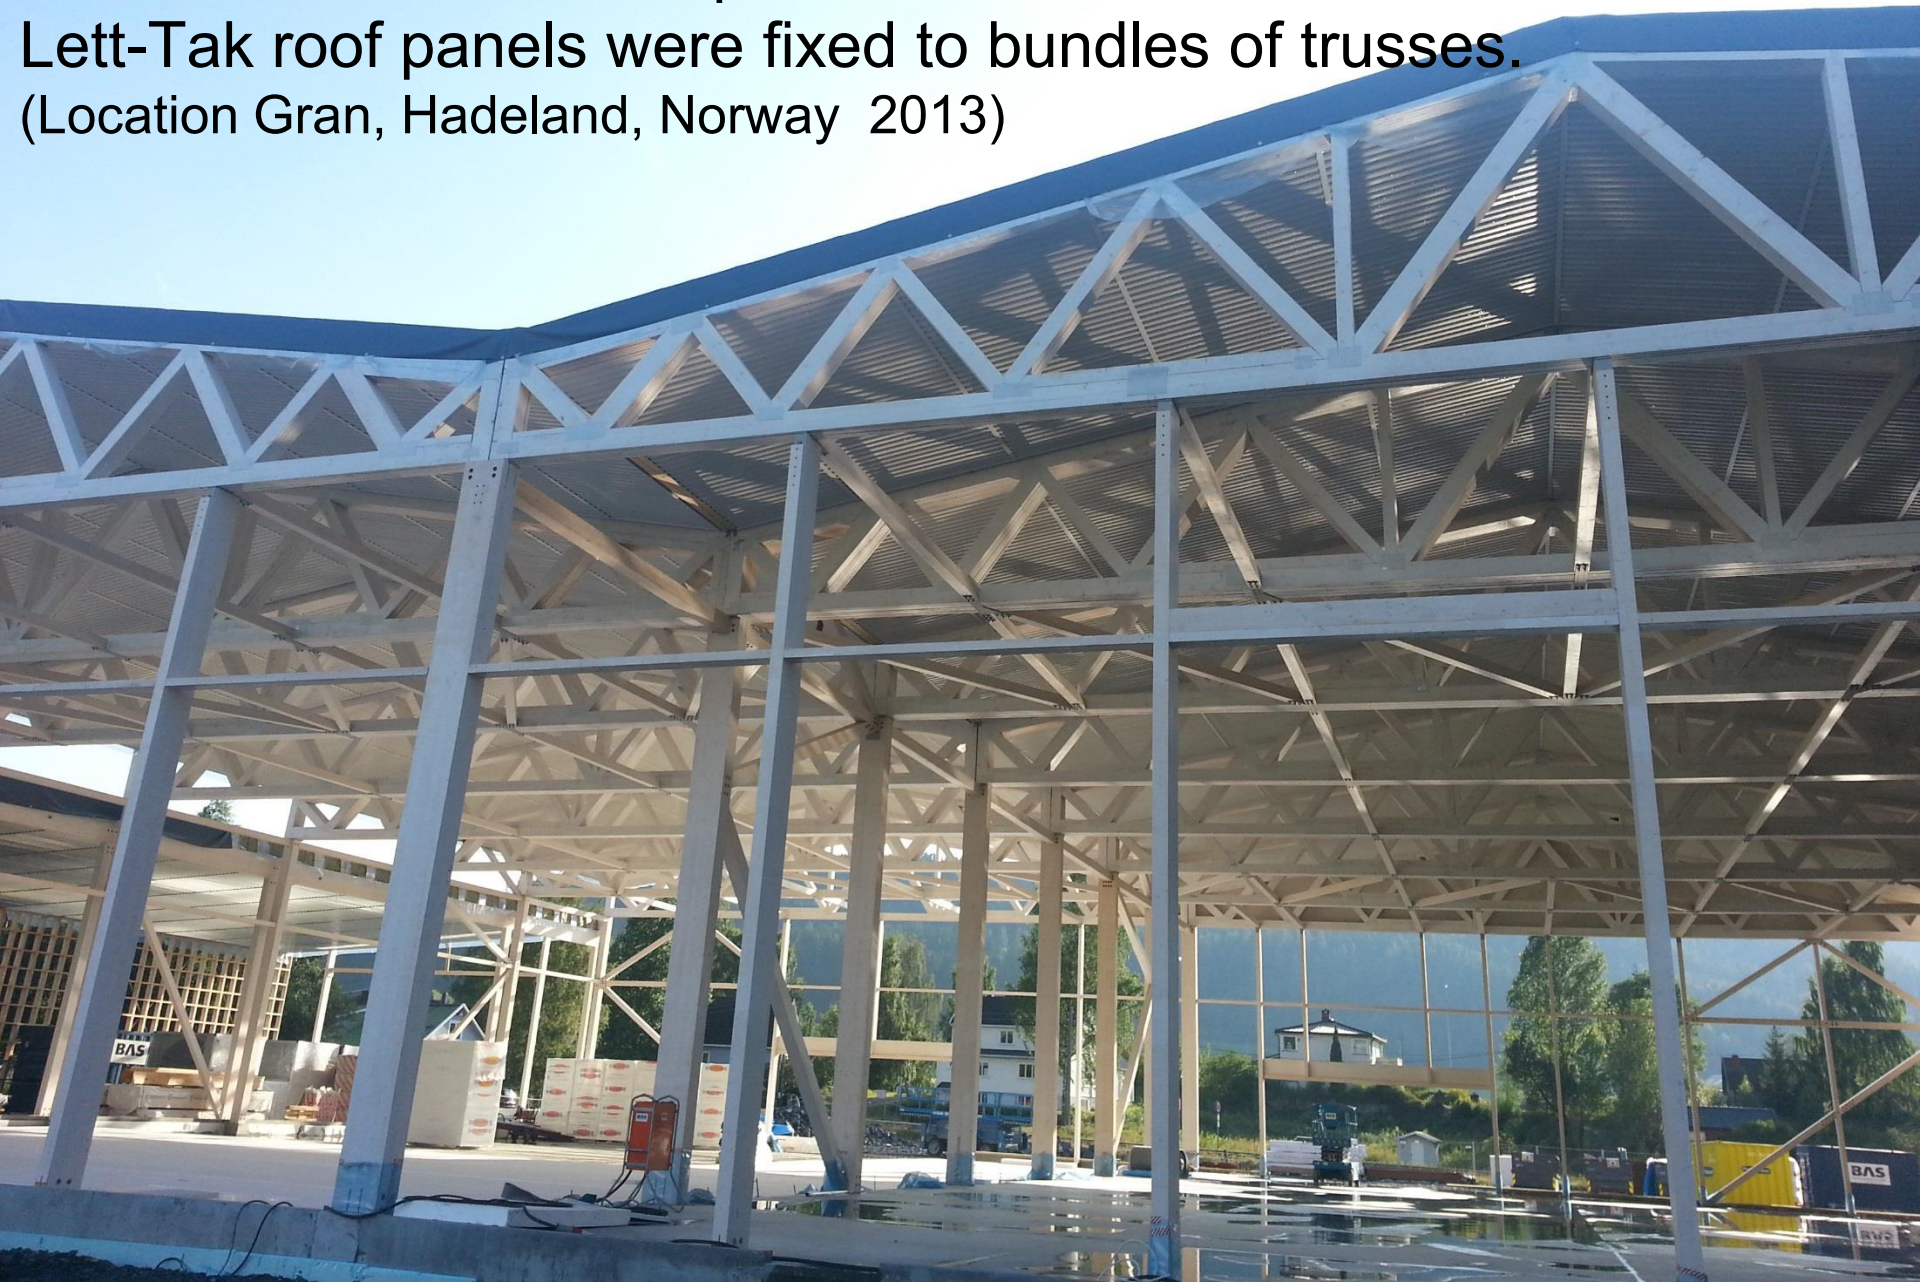
From 5 up to 9 trusses were collected in bundles to increase the fire resistance of the nailplate trusses.  
Lett-Tak roof panels were fixed to bundles of trusses.  
(Location Gran, Hadeland, Norway 2013)

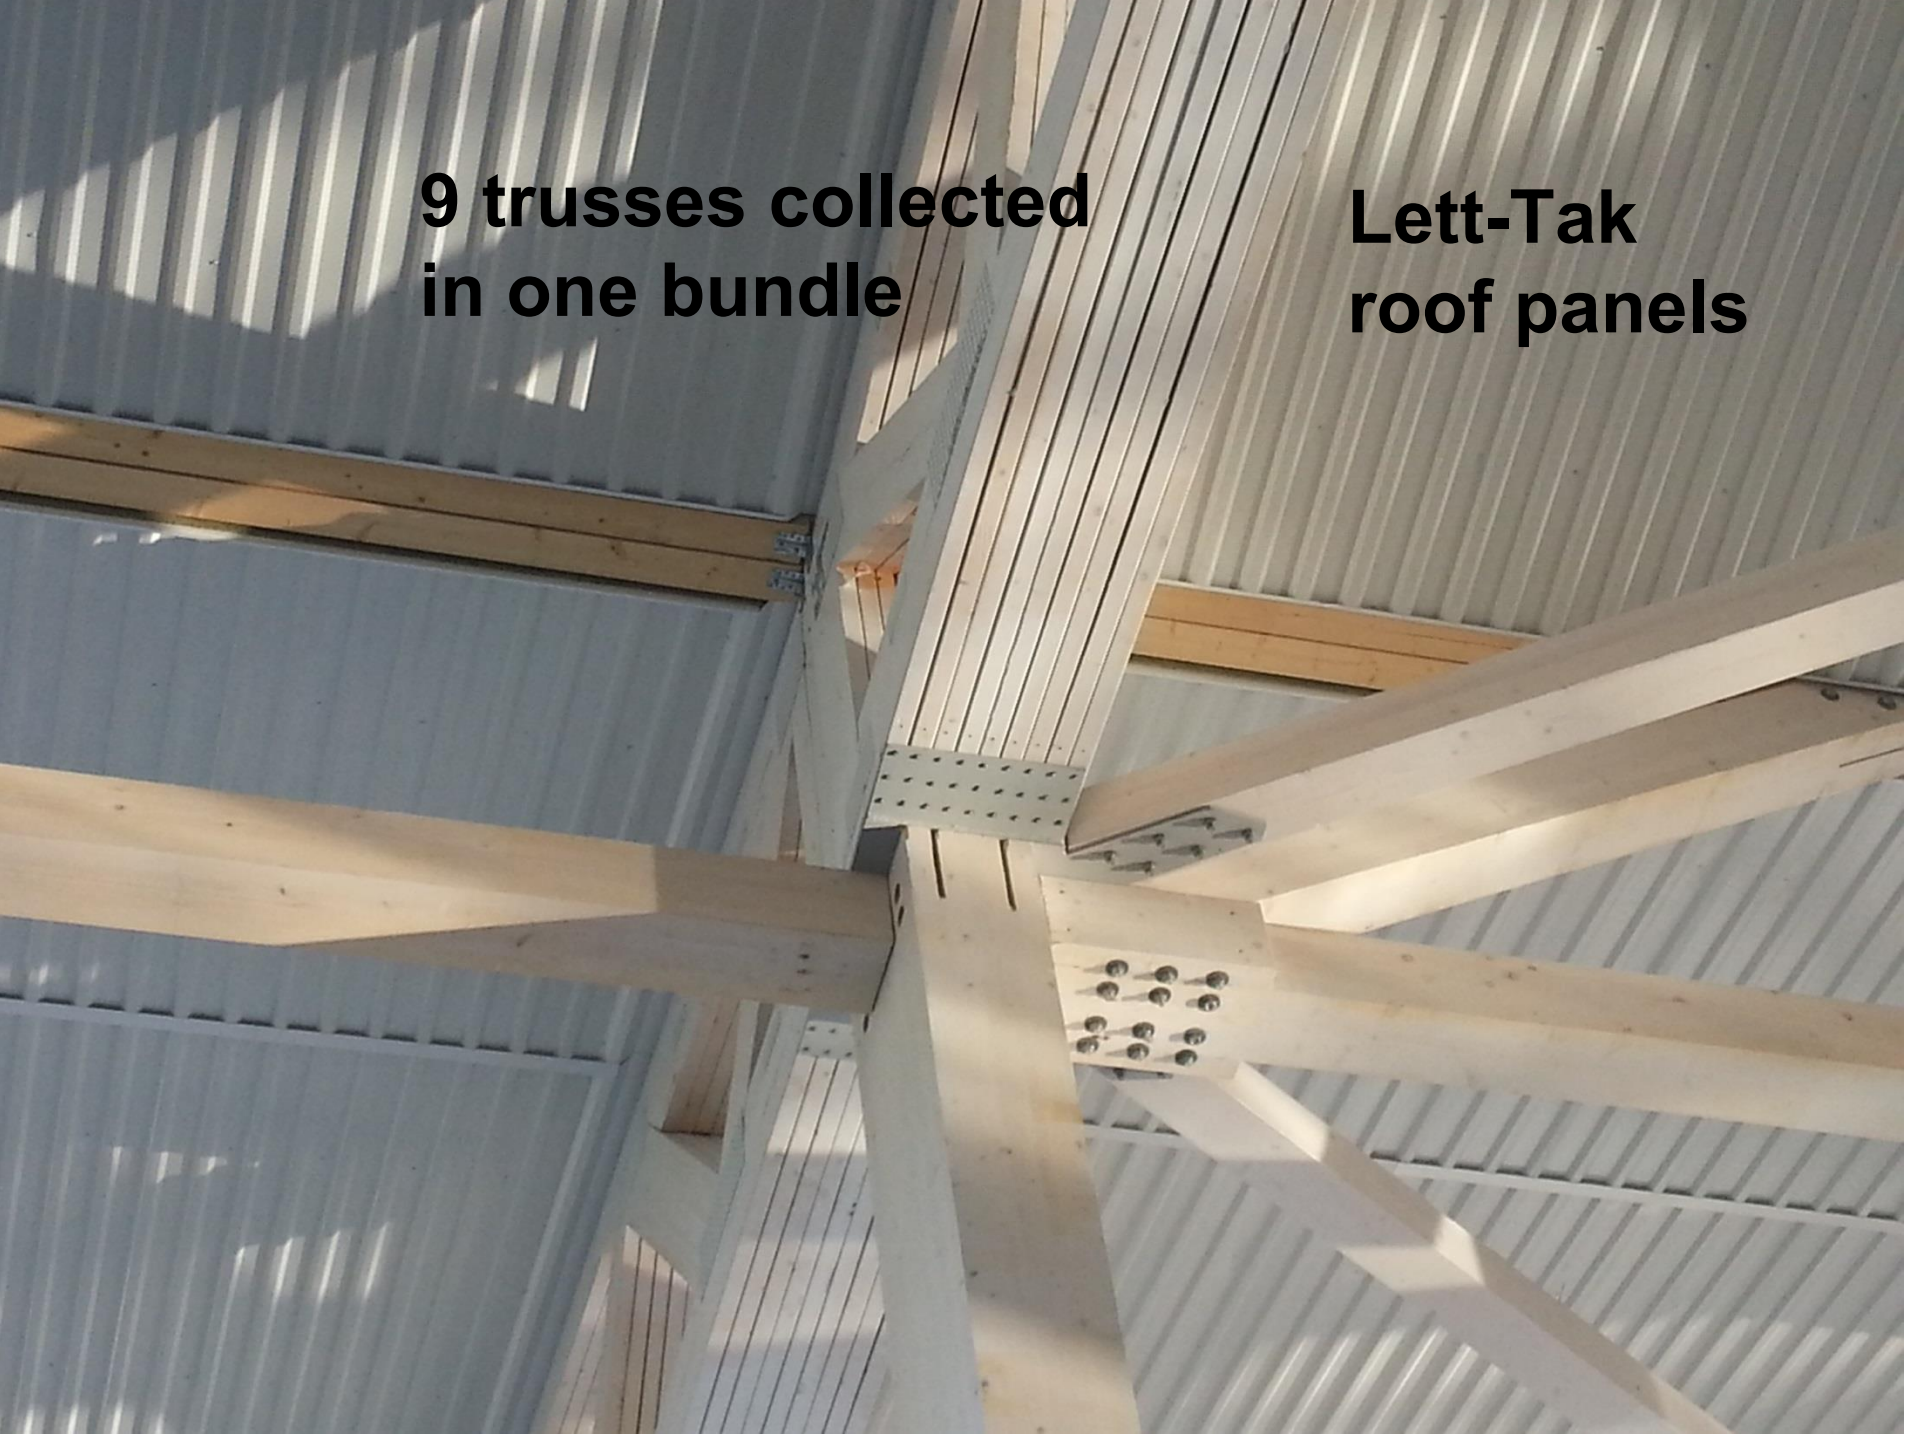
**9 trusses collected  
in one bundle**

**Lett-Tak  
roof panels**

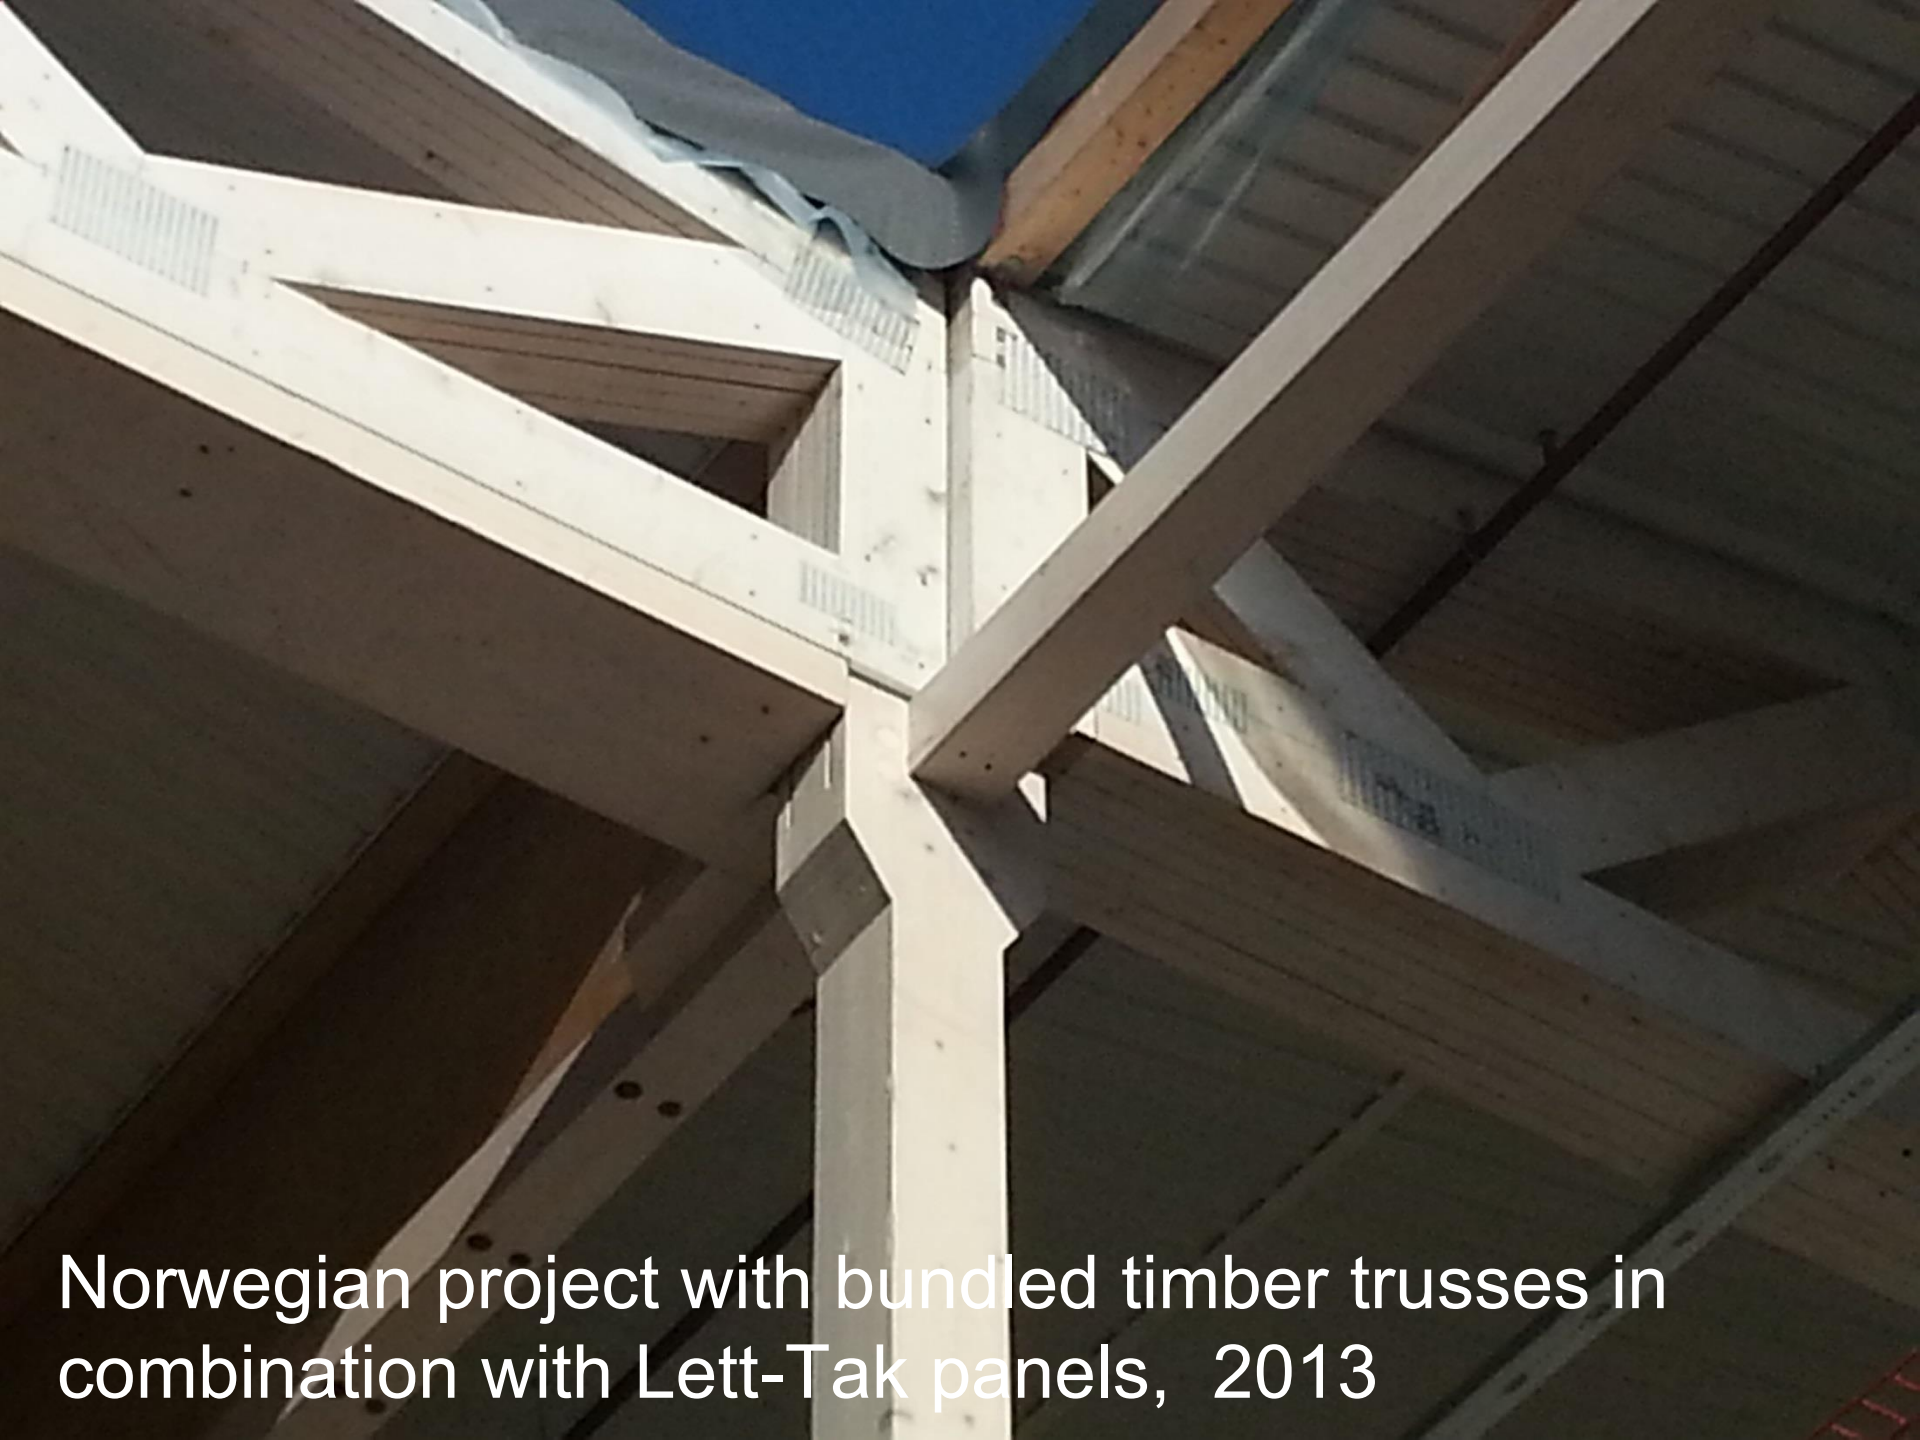
Timber diagonals in walls  
are leading forces down to  
the foundation

Norwegian project with bundled timber trusses in combination with Lett-Tak panels, 2013

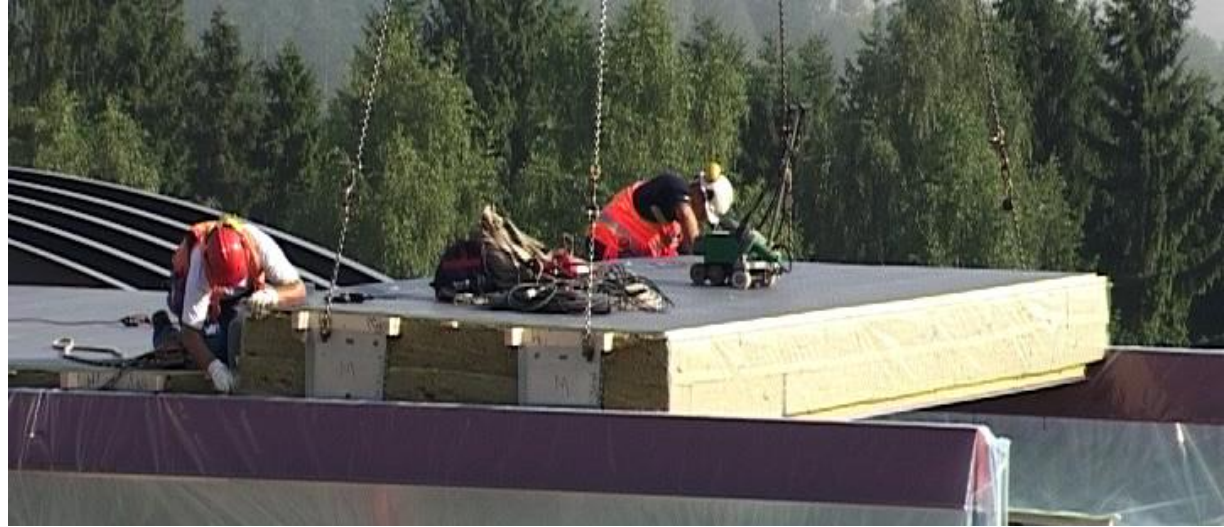
The Lett-Tak system also gives the possibility for diaphragm action of the roof. The roof panels are taking care of the **shear flow** in the diaphragm. elementer

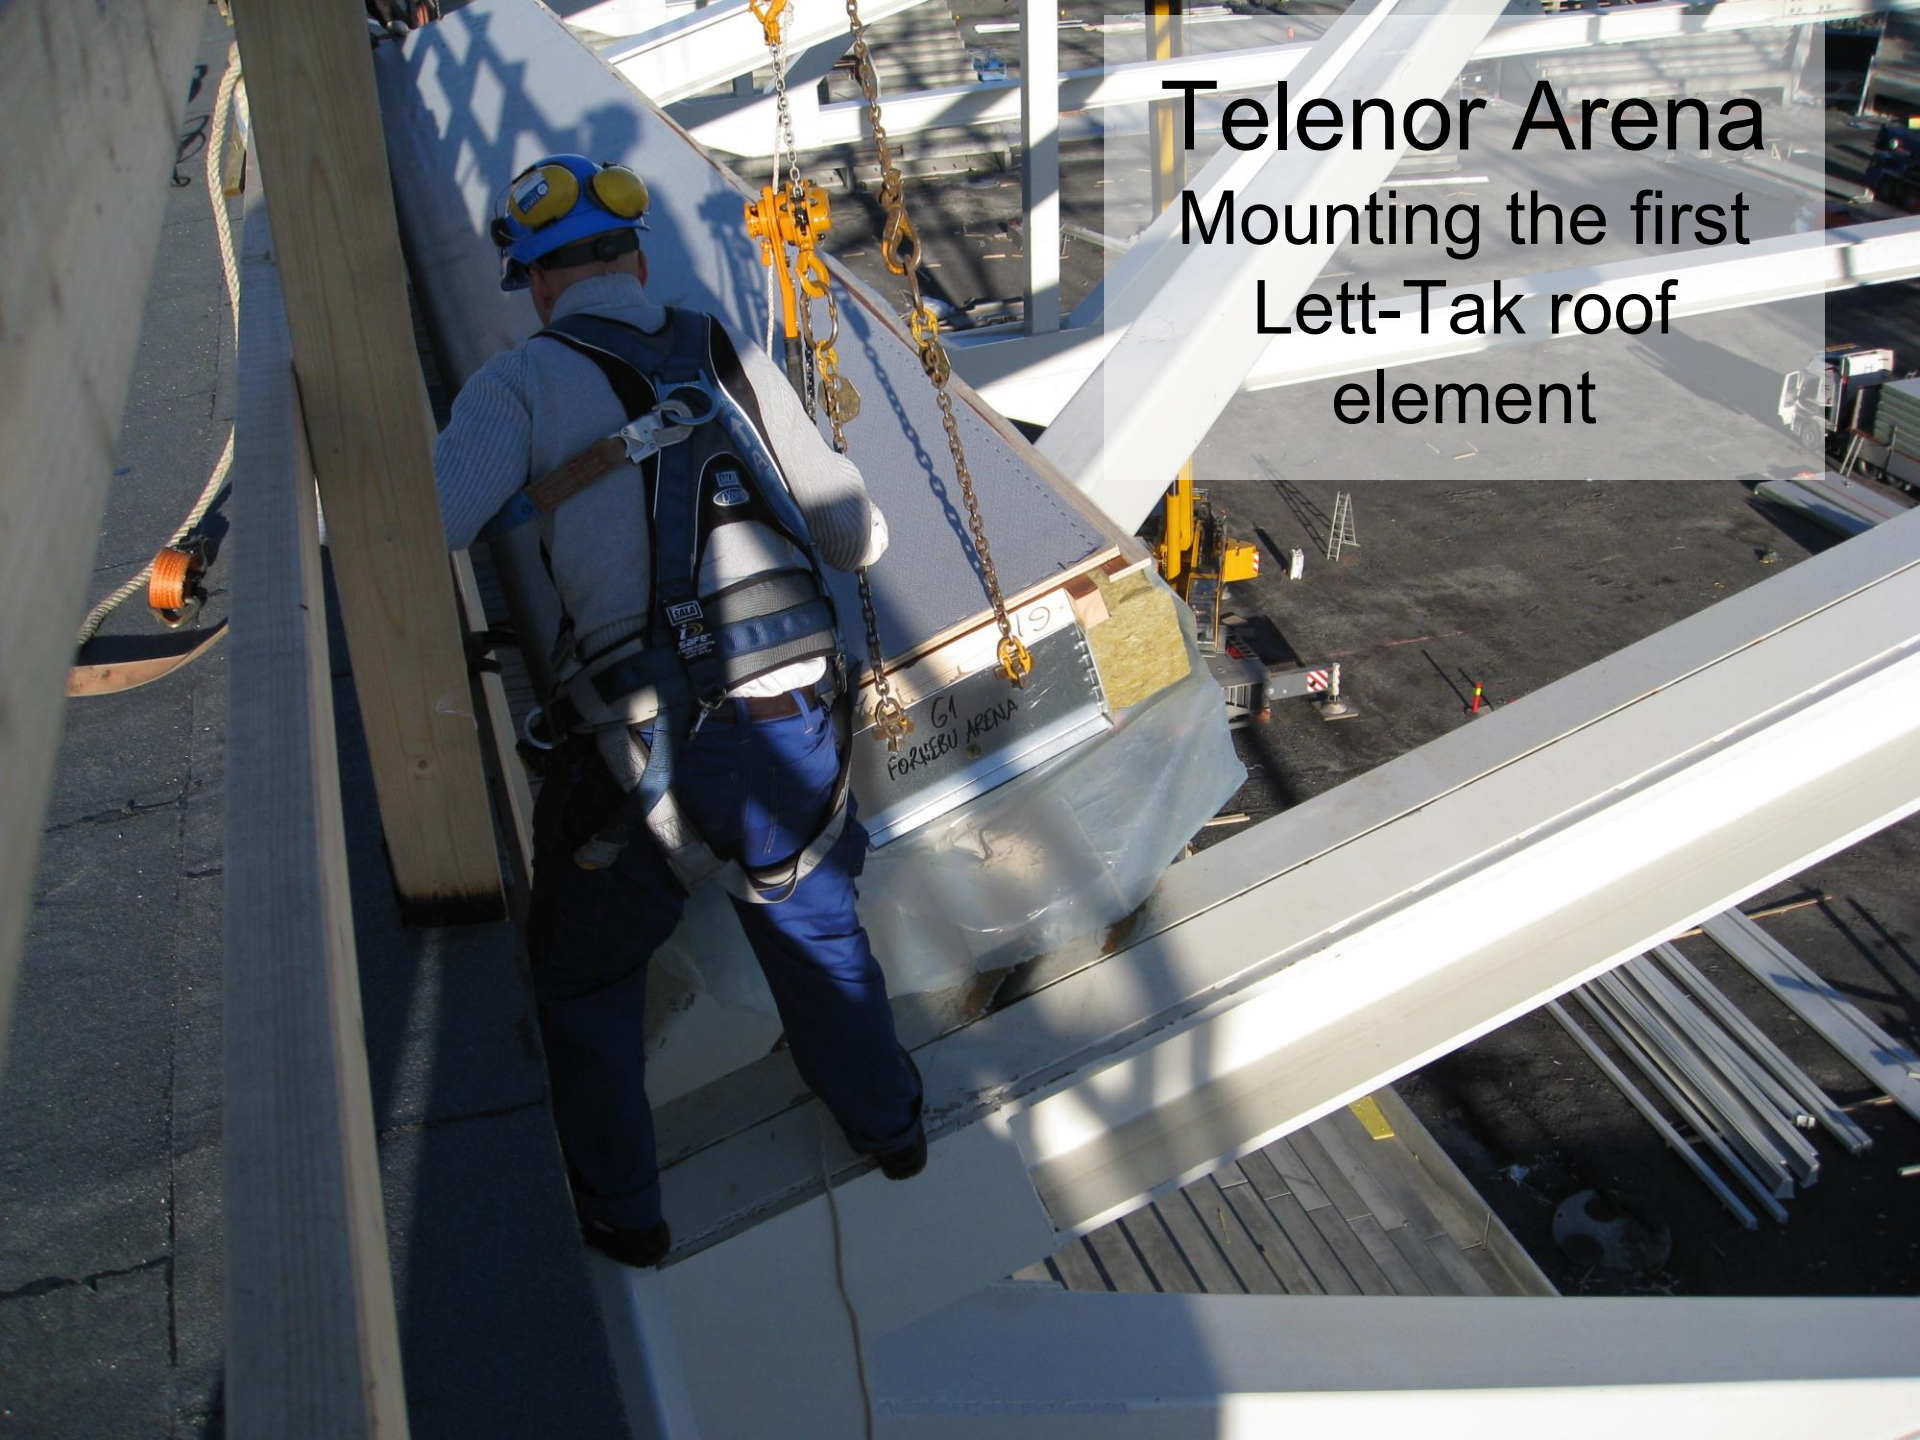
# Telenor Arena

## Mounting the first Lett-Tak roof element

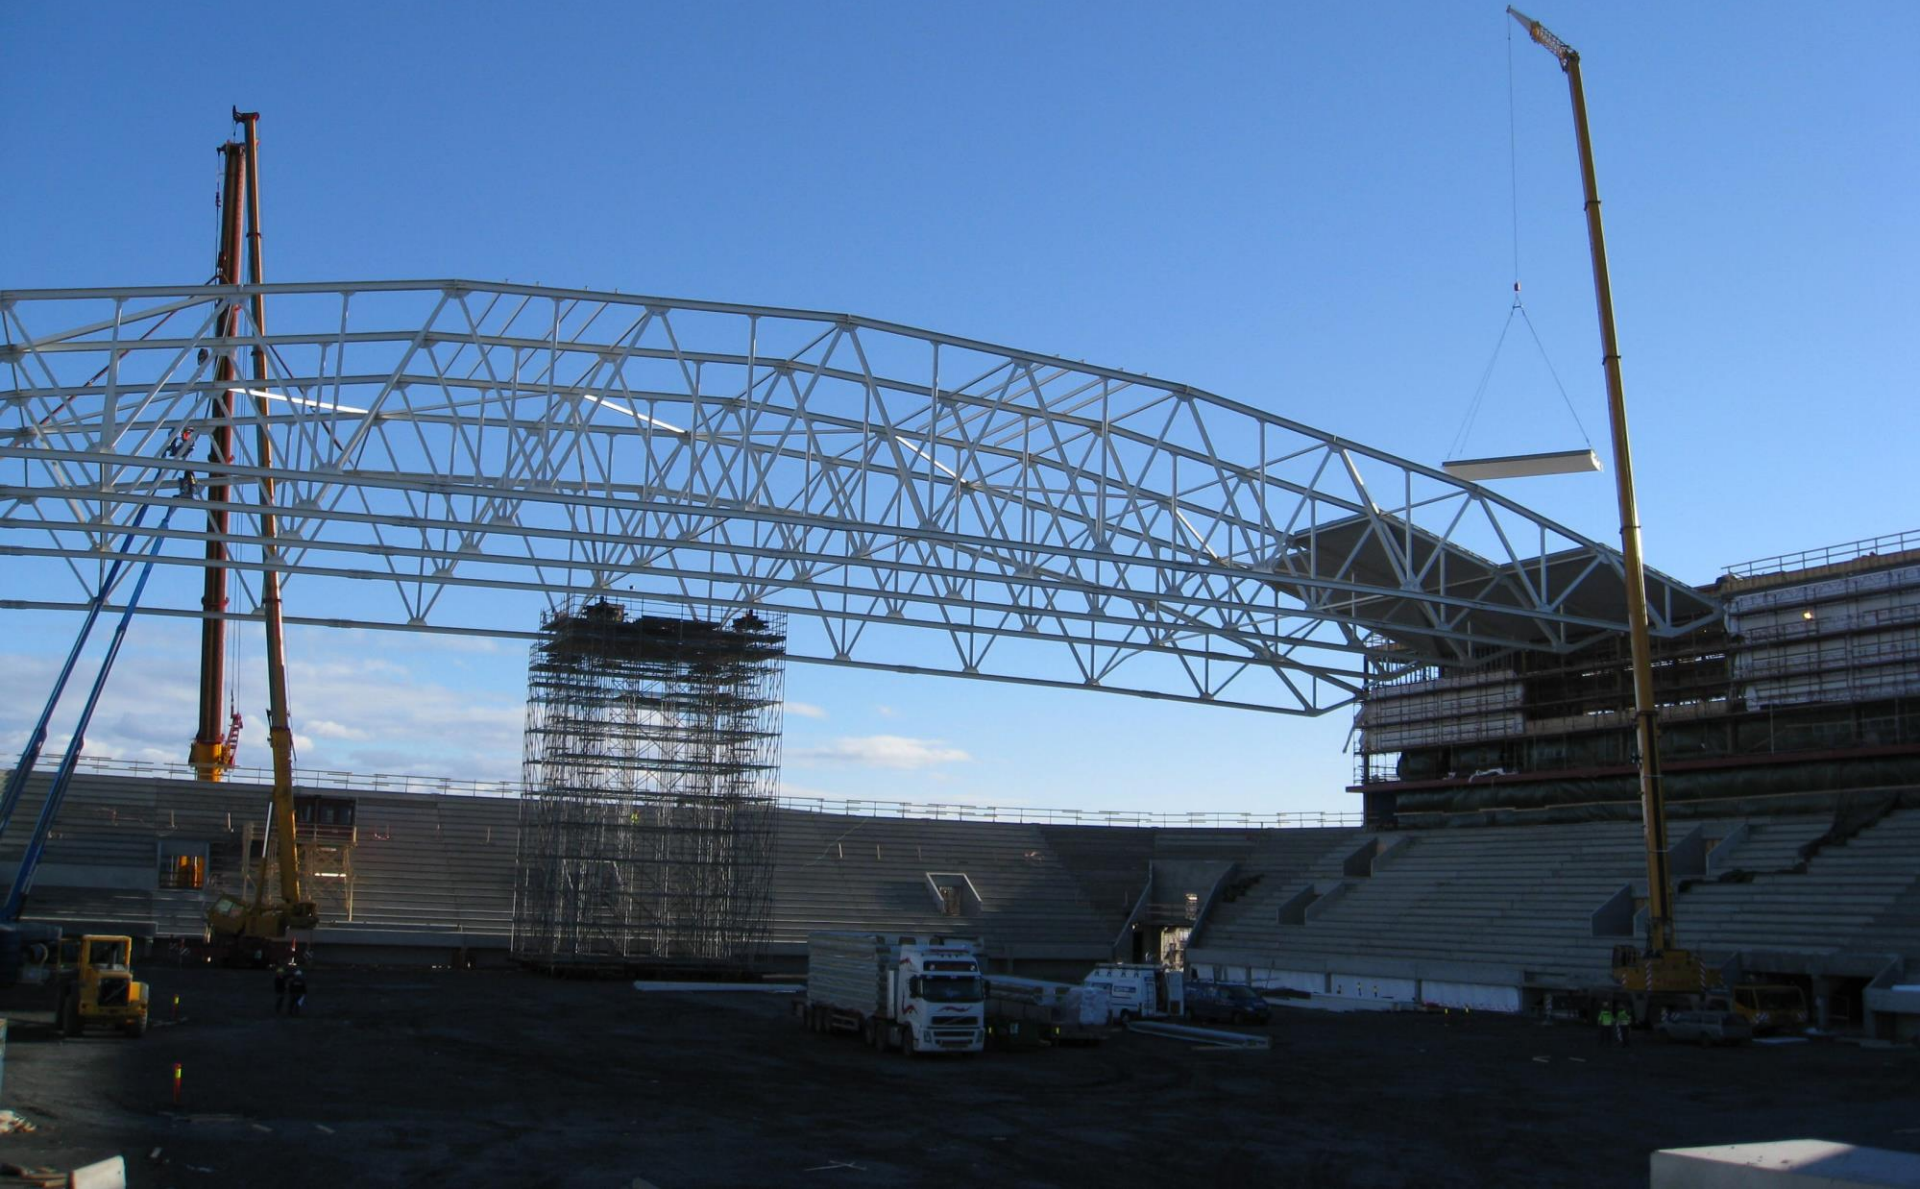
# Telenor Arena – Football and event hall

Covered and stabilized with Lett-Tak roof elements
