# Long Span Timber Structures with Composite Action – from disaster to success

Nils Ivar Bovim  
Norway

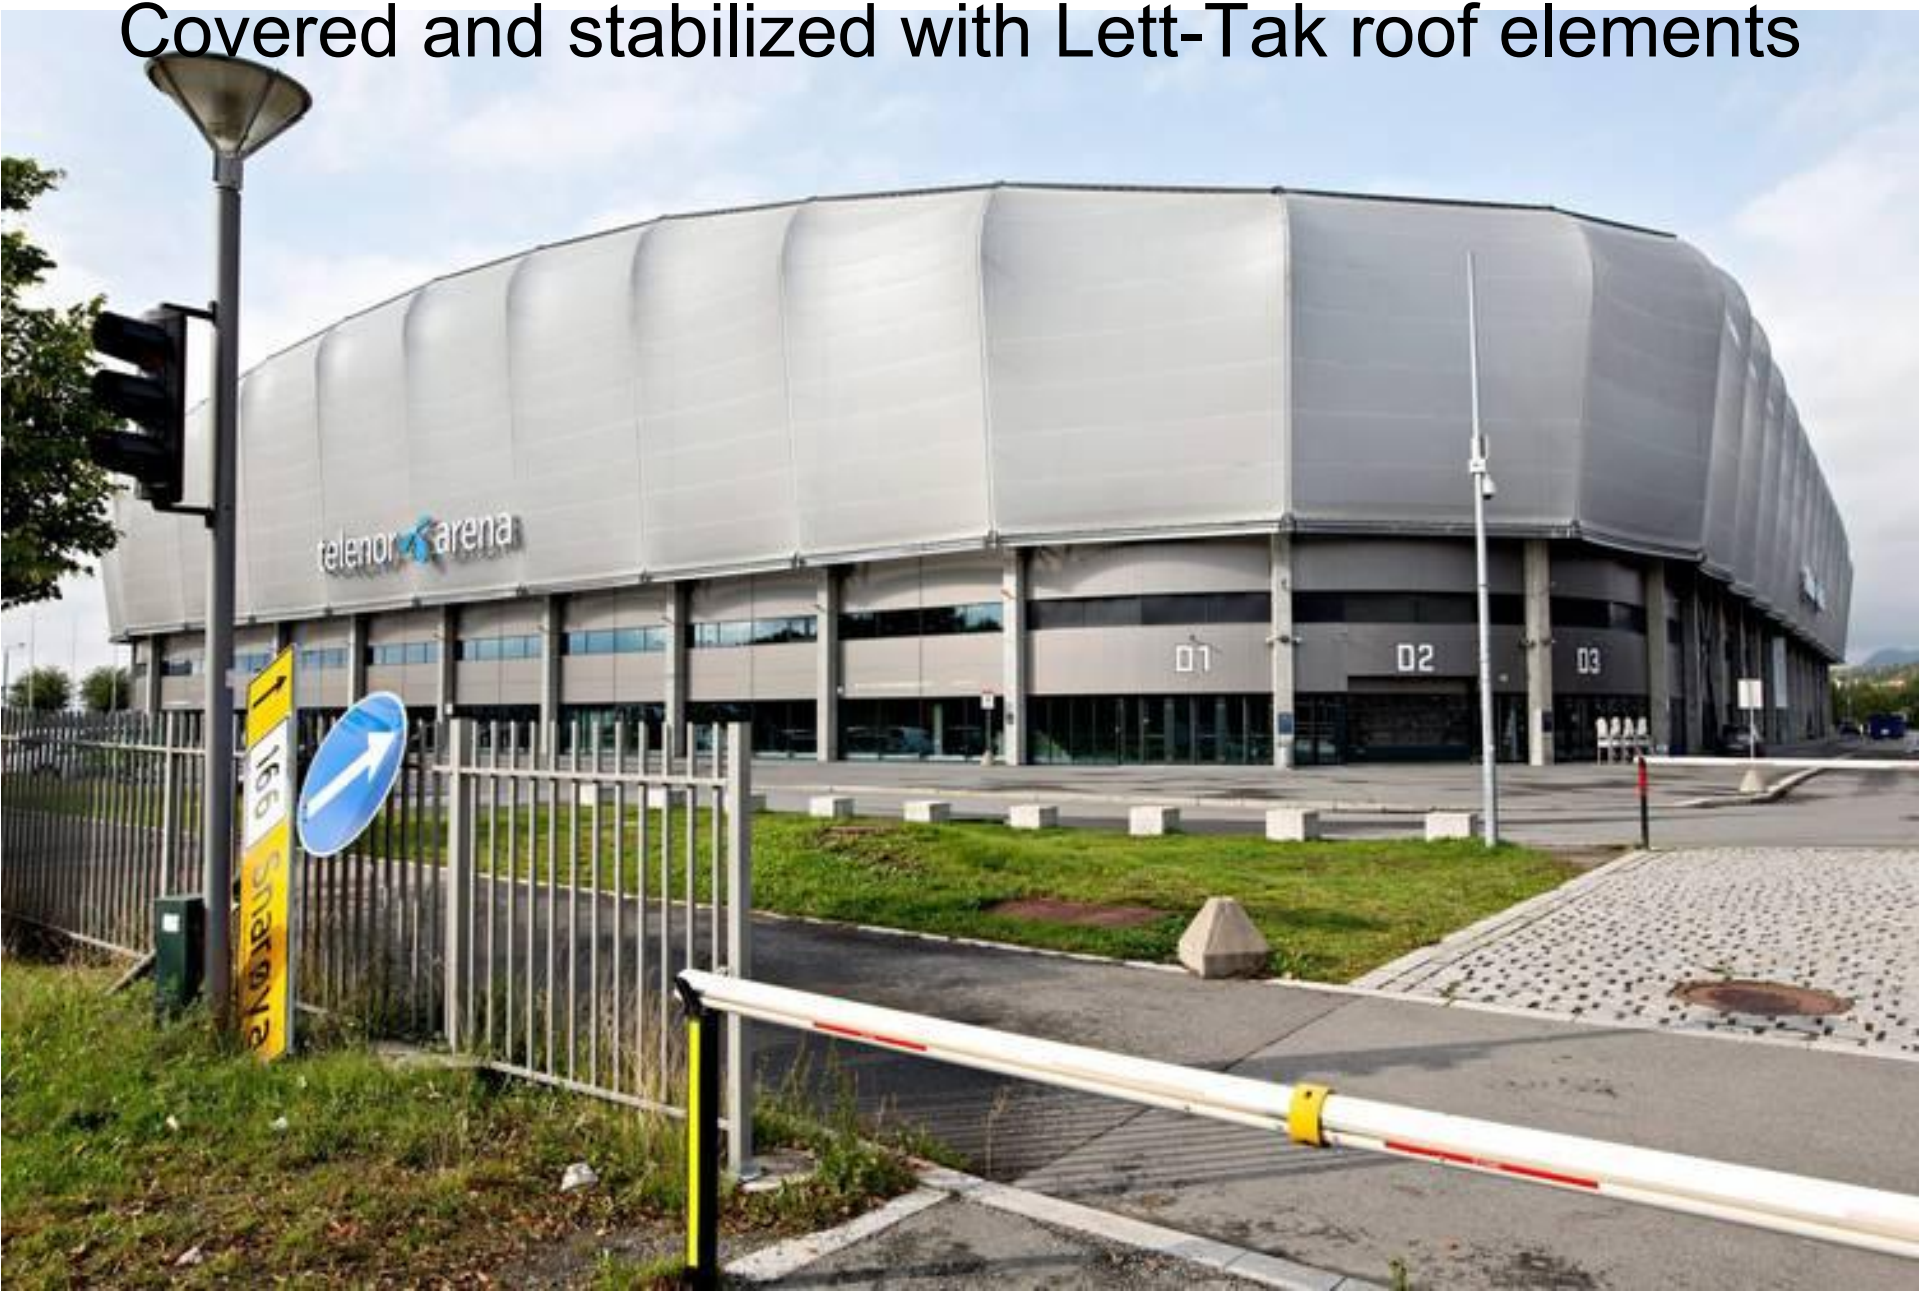
# Telenor Arena – Football and event hall

Covered and stabilized with Lett-Tak roof elements

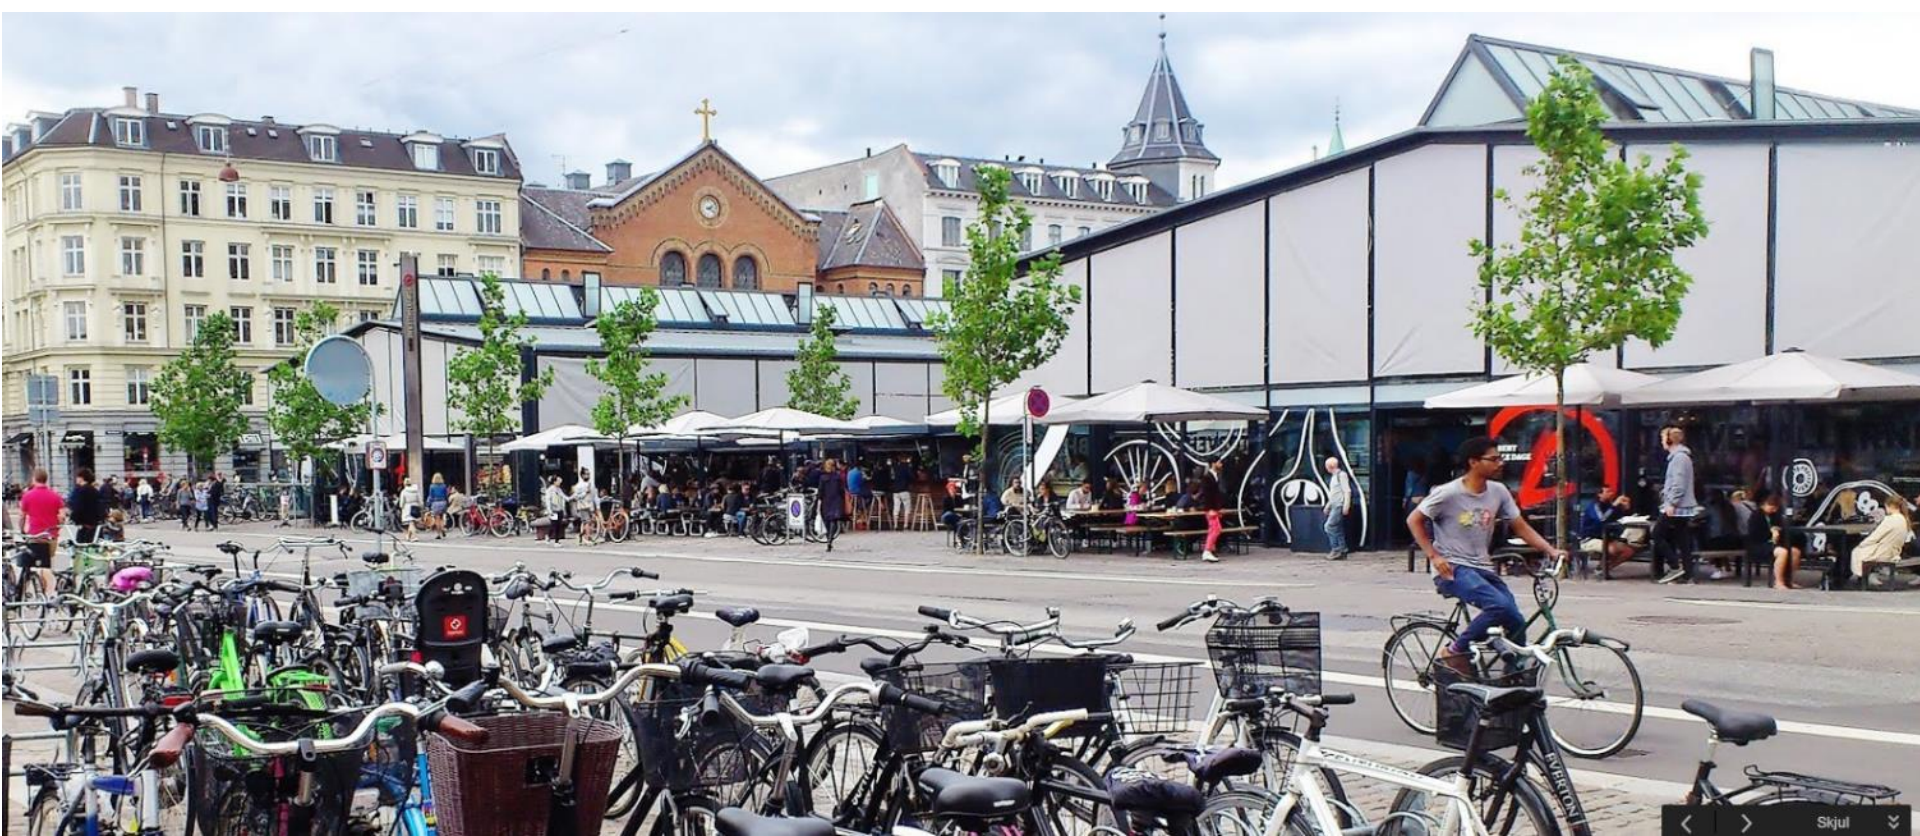
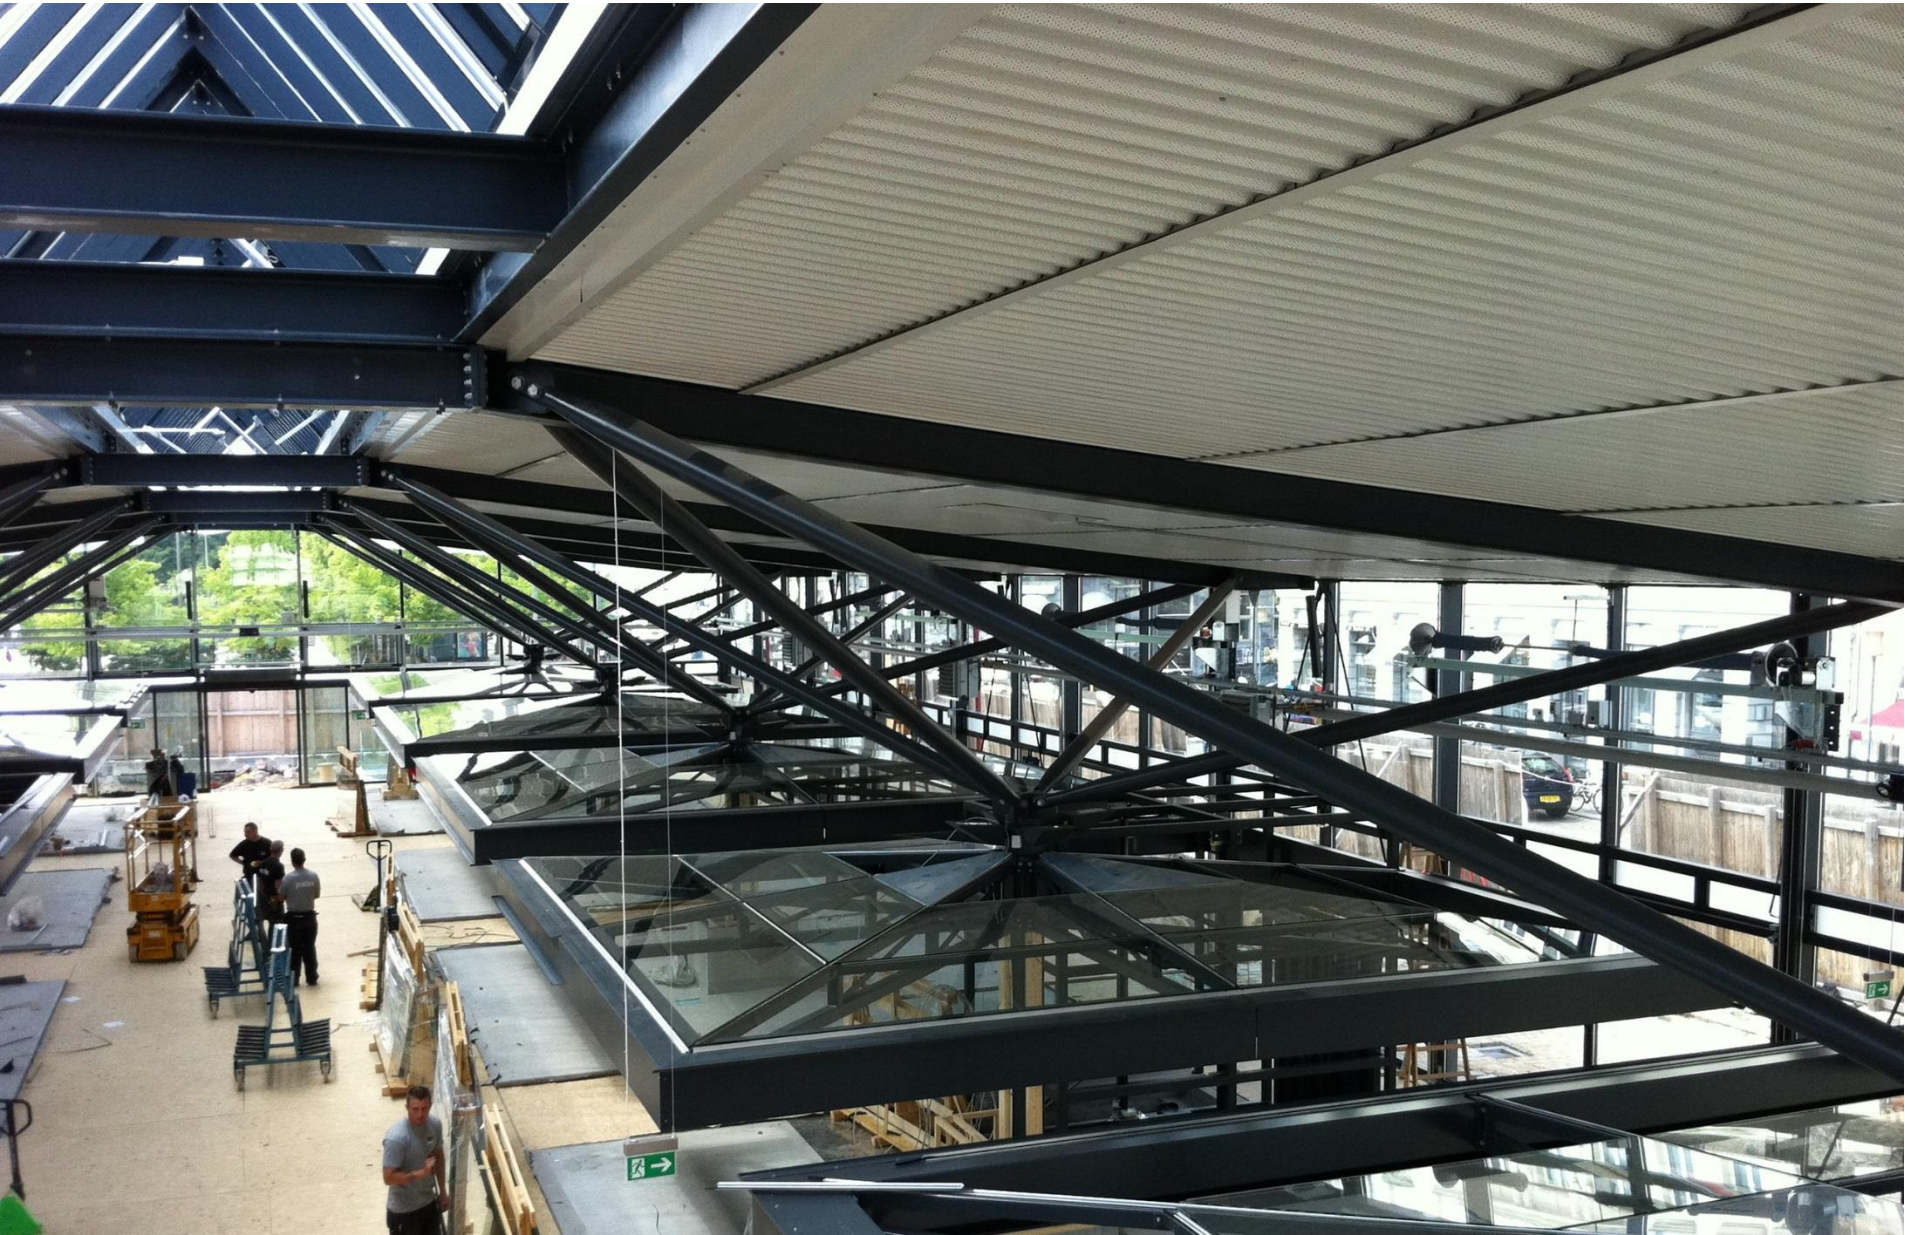
# Torvehaller – in the centre of Copenhagen

A relatively soft (and weak) steel structure.

Stabilizing the whole buildings is an important function of the Lett-Tak roof panels in this project.

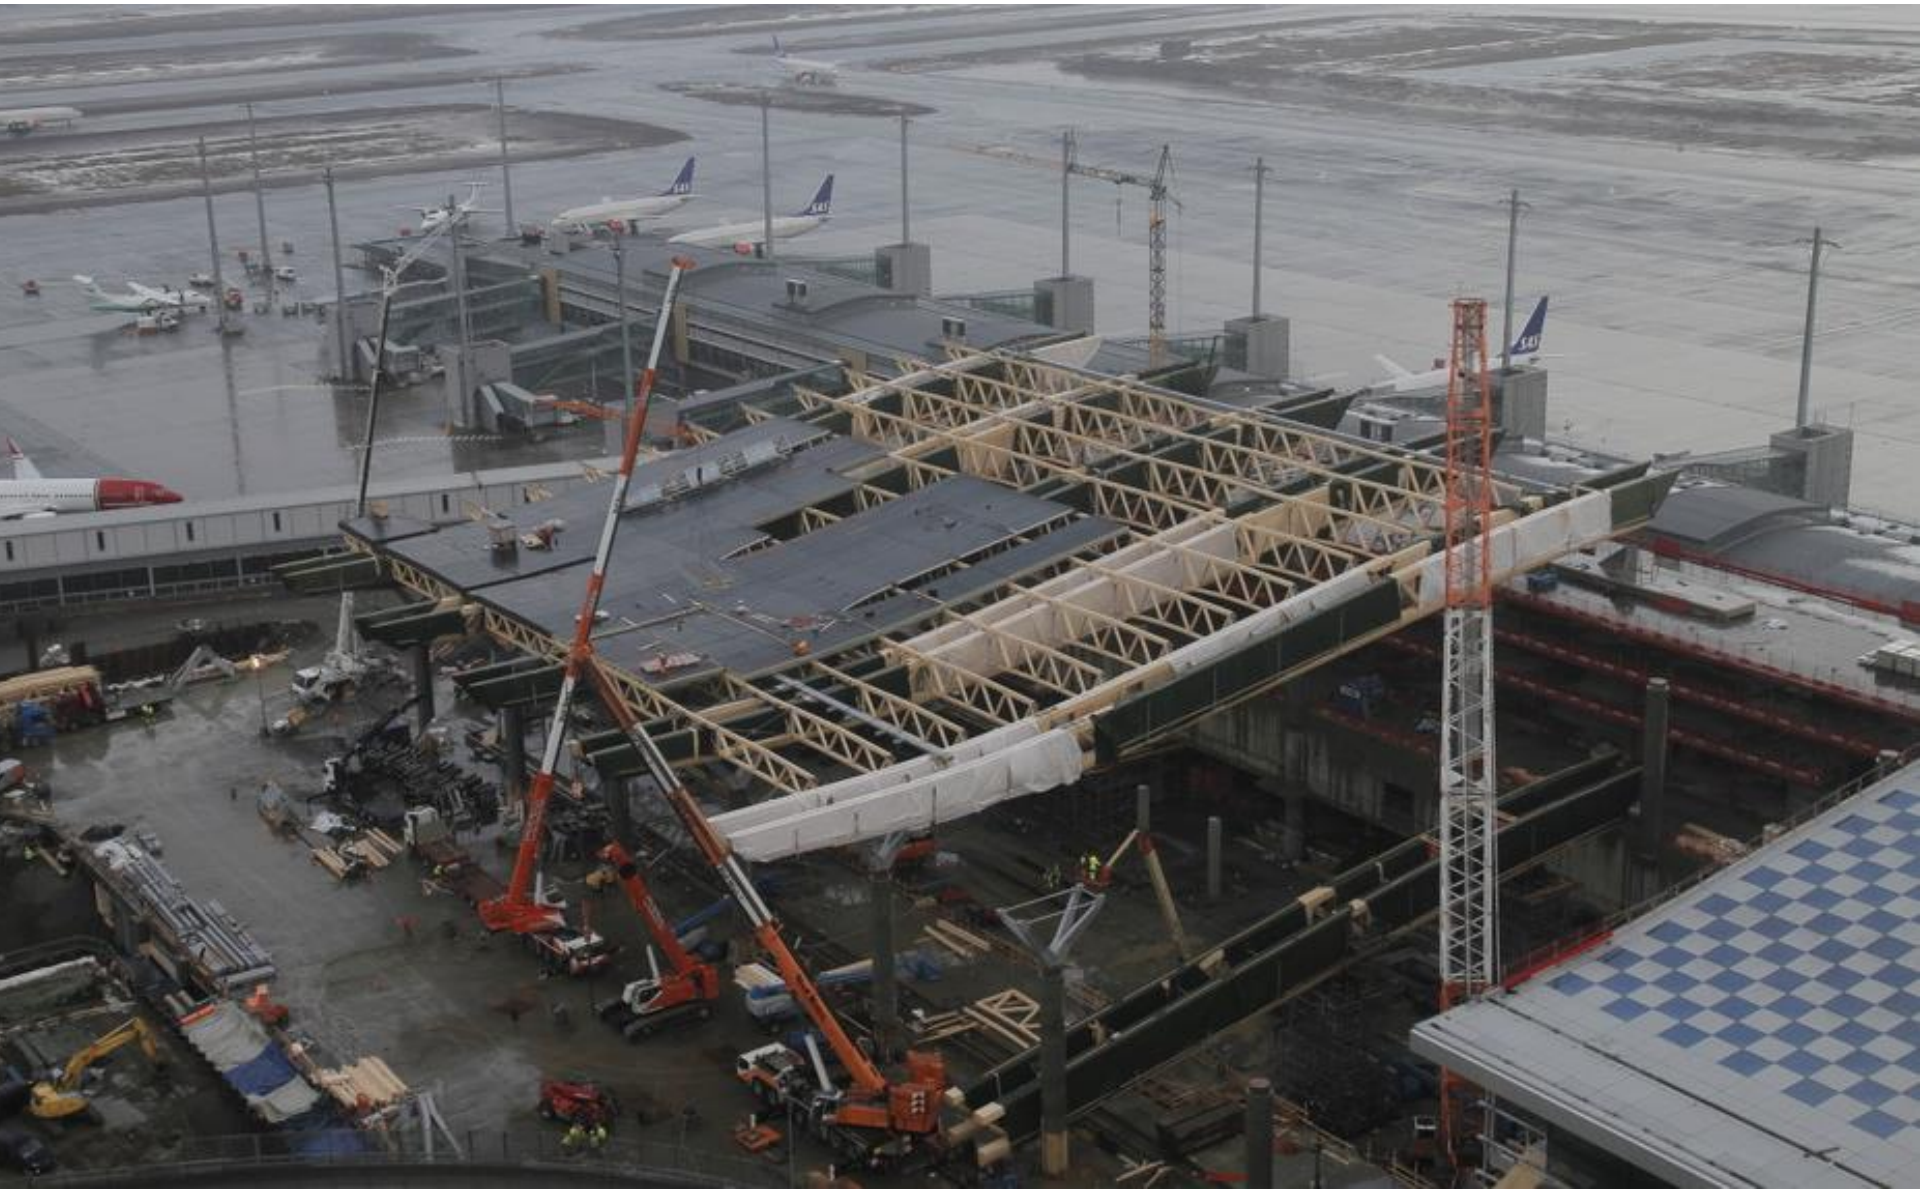
# **New inland terminal – Gardermoen airport 2014**

## **Main structure of Glulam, covered and stabilized with Lett-Tak roof panels**

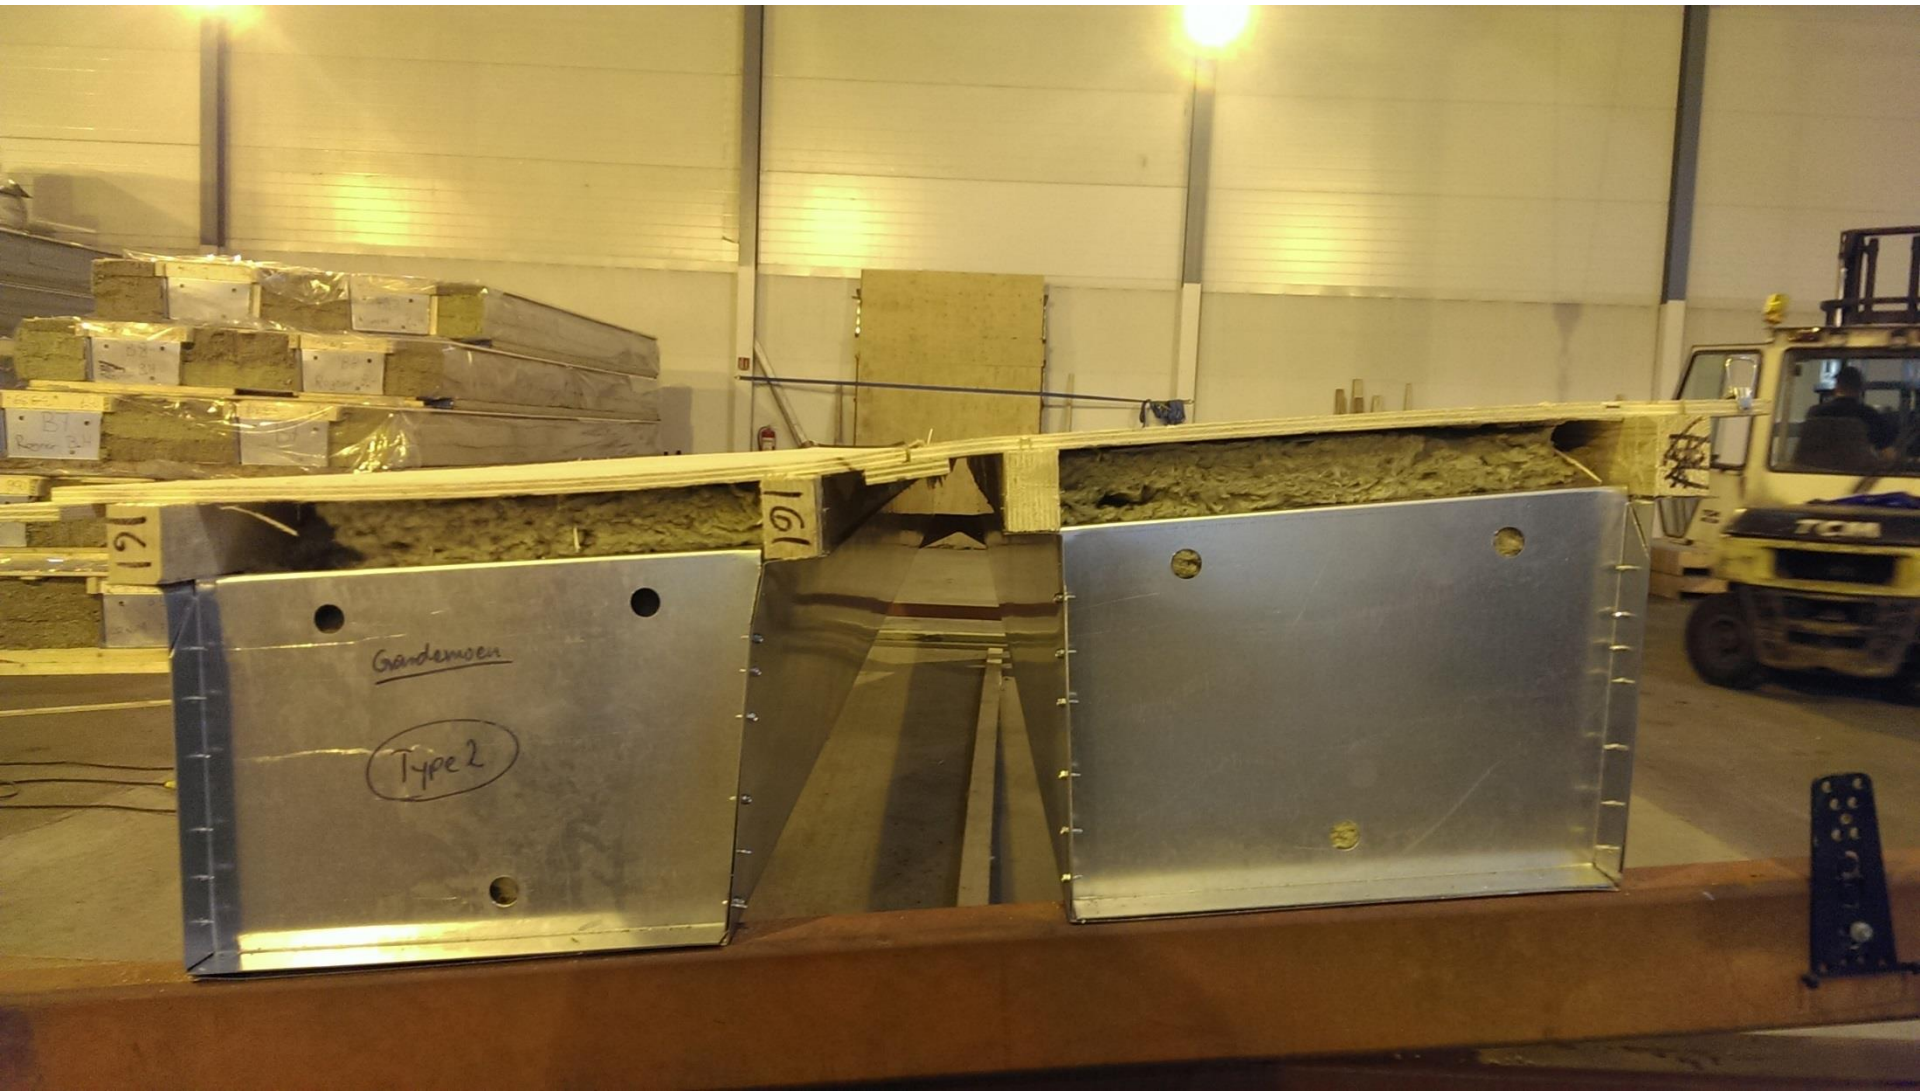
# Gardermoen Pir North 2014

- The roof panels in some part of the roof had to be twisted (double curved shape)  
Picture from the factory, testing twisting of roof panels
- Even if the panel is soft in the transverse direction, twisting up to  $10^\circ$  of 9 m long roof panels could be a challenge. Some steel end plates had to be skewed!
